Umstead Correctional Center Building Assessment

Prepared for
The Town of Butner, North Carolina

12-18-19

HagerSmith Design

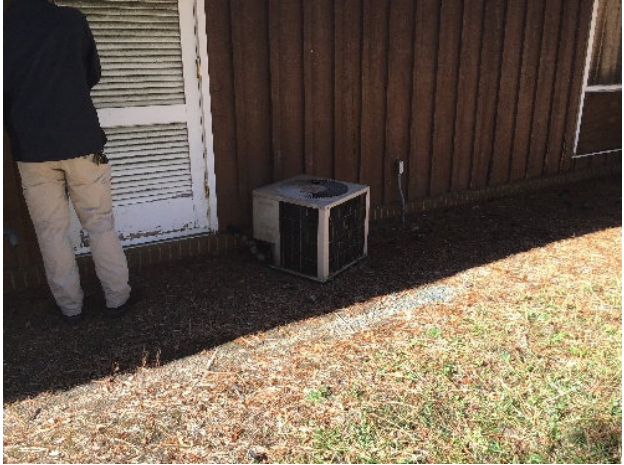
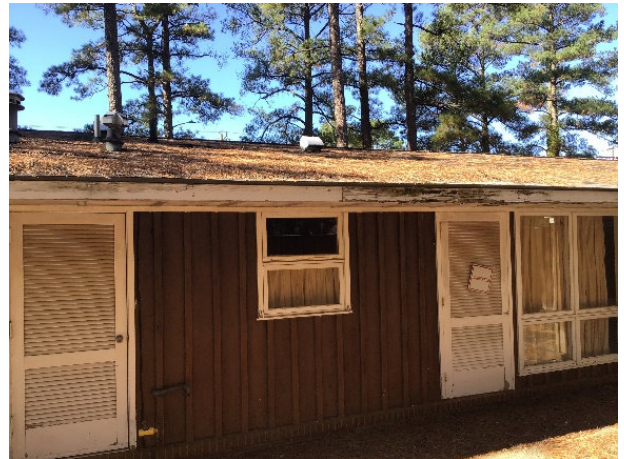
The exterior wall construction for this structure consist of wood siding and masonry end walls. The windows are wood framed with single pane glass. The doors are wood and wood louver doors. The wood siding is in fair condition and the brick portions of the wall are in good condition. The windows and doors are in poor condition and are showing signs of water damage and decay. Signs of water leakage is evident at the window/frame connections and at the floor level of the exterior doors.

The roof is an asphalt shingle roof that is showing signs of failure. Debris and shingle deformities are evident on the roof. Our team was not able to gain access inside the building but based on the teams through the window visual inspection there were some signs of leakage, but no major leaks were observed.

This structure is in immediate need of repairs. It is unclear what damage may exist in the floor system or in the interior framing. A complete interior gut will most likely have to take place in order to mediate the mold and mildew damage. All door and windows will have to be replaced and a new roof, including some underlayment will also have to be replaced in order to save the structure from further decay. Further inspections will be required to ensure no termite damage exist.

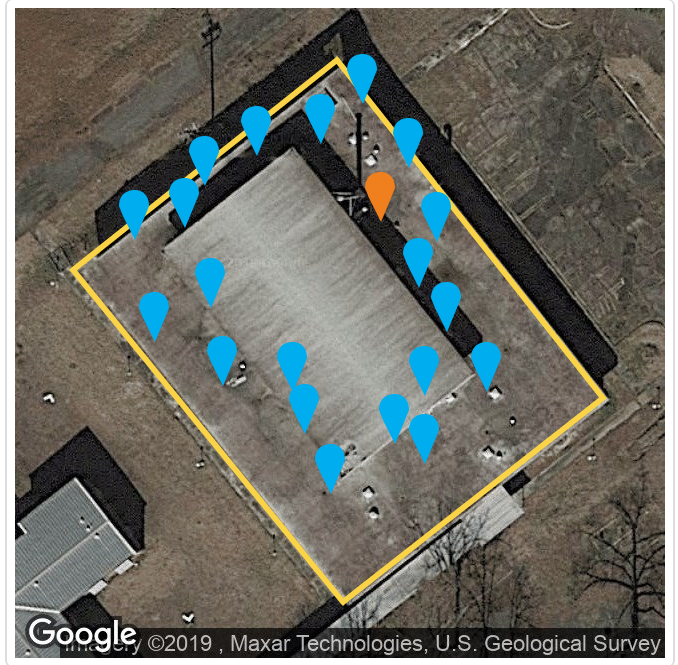
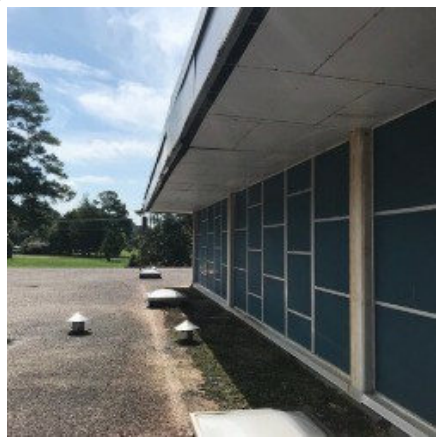
Figure 1

A roof top environment that is rich with moisture and air born dirt and particulates can be the breeding ground for seeds.

Requires Repair

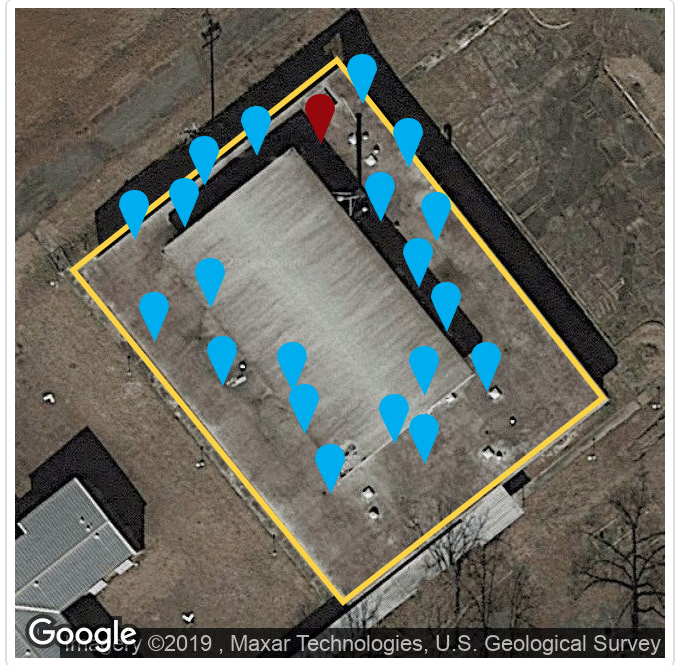
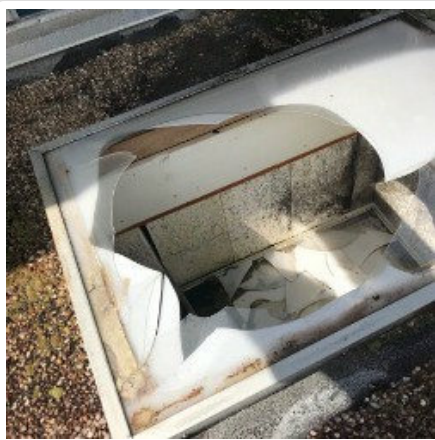
Figure 1

Issue AI-5: Skylight/Curb Damaged

Requires Repair

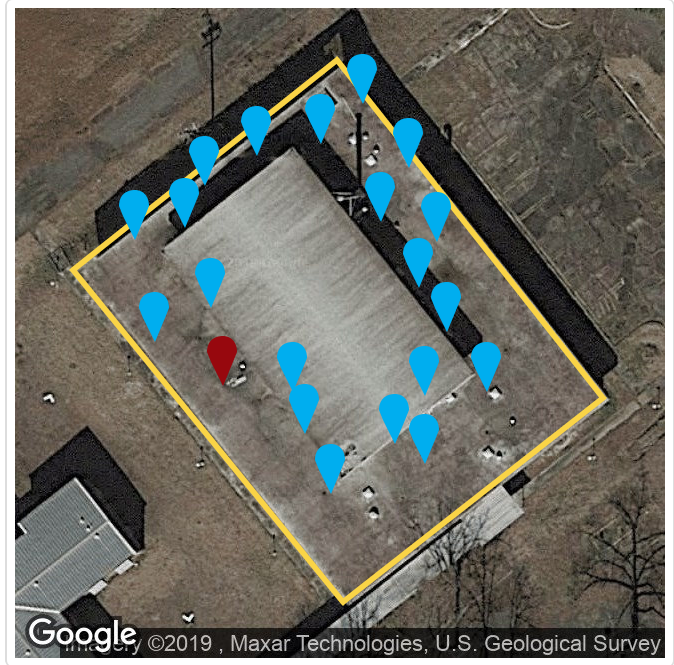
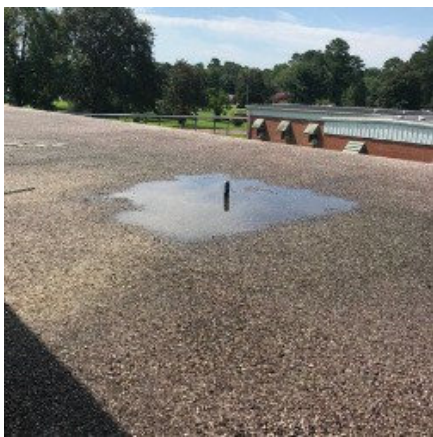
Figure 1

The NRCA has classified "undesirable" ponding water as standing for more than 48 hours, though ponding can pose a threat in even shorter time spans. Since ponds occur in low areas of a roof, a pond becomes a repository for debris, sediment, and chemical

emissions. Ponding encourages microorganism and bacterial degradation, roof deflection, magnified ultraviolet exposure and premature failure of the roof system. A matter of "deep" concern in the roofing industry is the fact that a 1" deep pond weighs 5.2 lbs. / sq. ft. and many structures cannot handle this extra load.

Major

Requires Repair

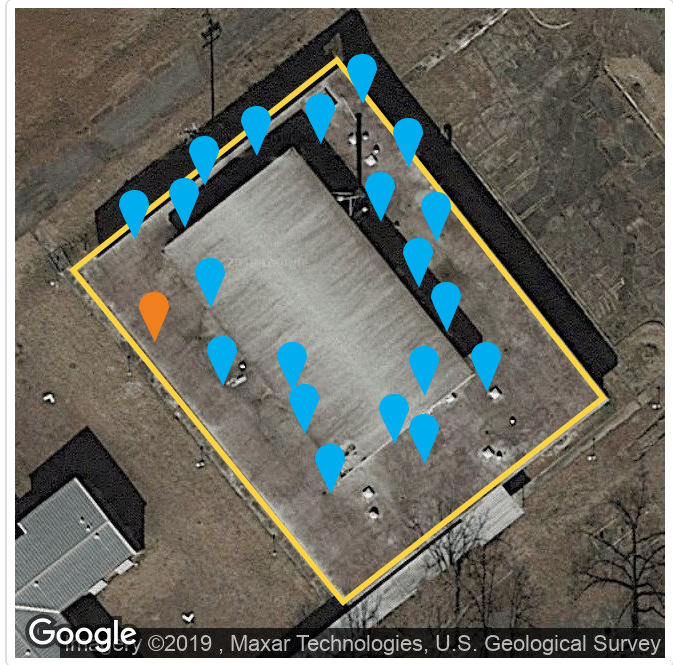
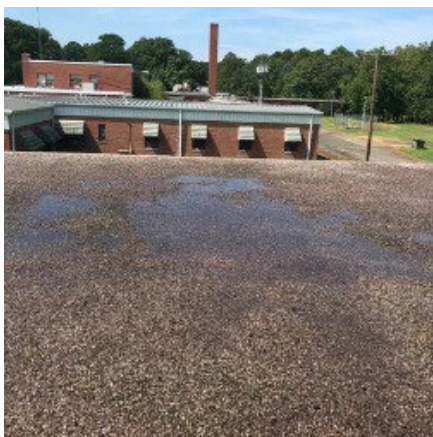
Figure 1

The NRCA has classified "undesirable" ponding water as standing for more than 48 hours, though ponding can pose a threat in even shorter time spans. Since ponds occur in low areas of a roof, a pond becomes a repository for debris, sediment, and chemical emissions. Ponding encourages microorganism and bacterial degradation, roof deflection, magnified ultraviolet exposure and premature failure of the roof system. A matter of "deep" concern in the roofing industry is the fact that a 1" deep pond weighs 5.2 lbs. / sq. ft. and many structures cannot handle this extra load.

Moderate

Requires Repair
