Umstead Correctional Center Building Assessment

Prepared for
The Town of Butner, North Carolina

12-18-19

HagerSmith Design

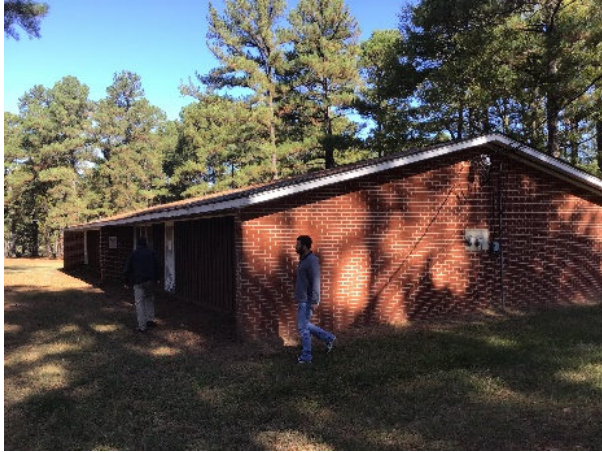
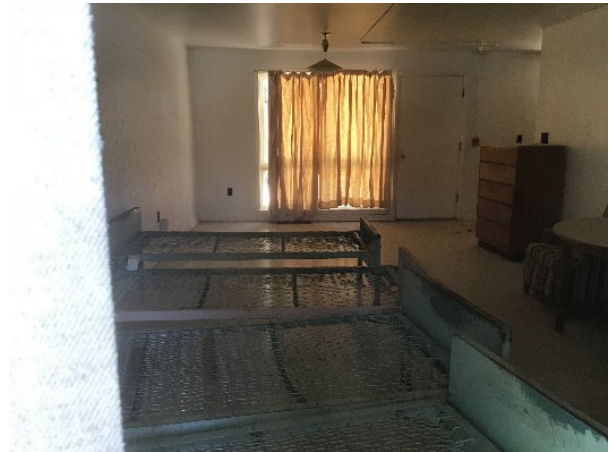
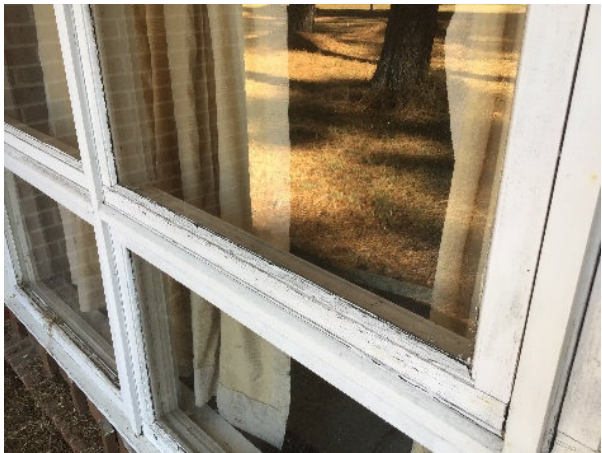
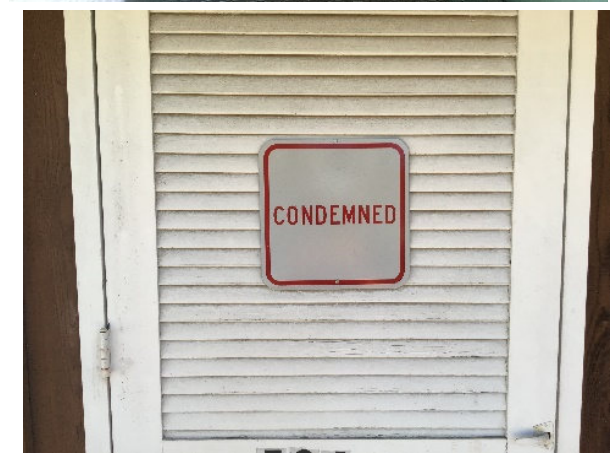
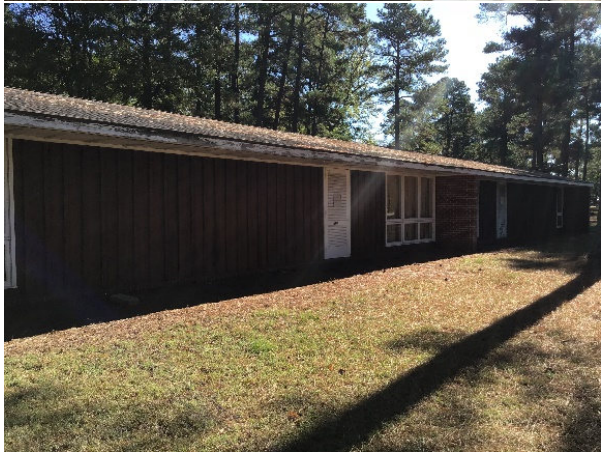
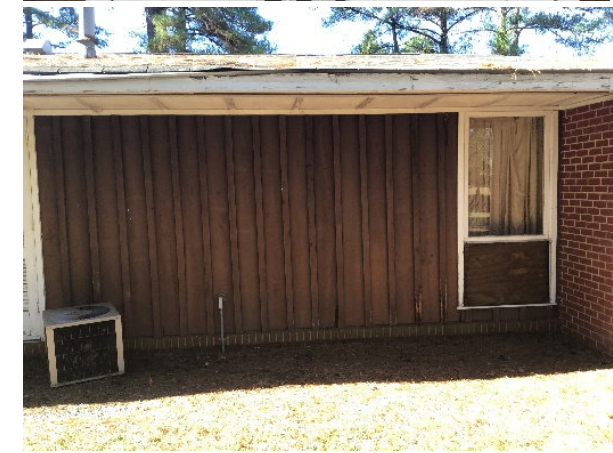
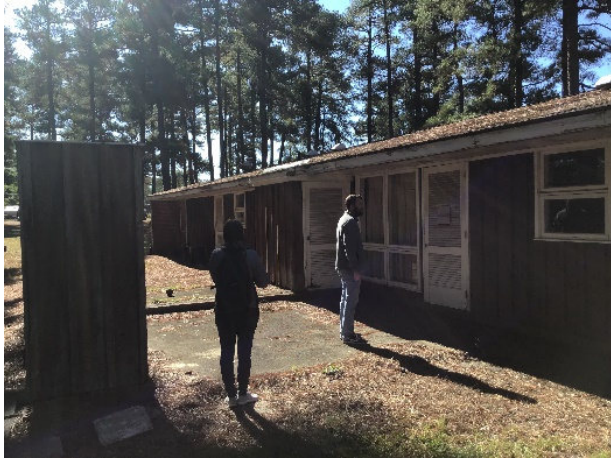
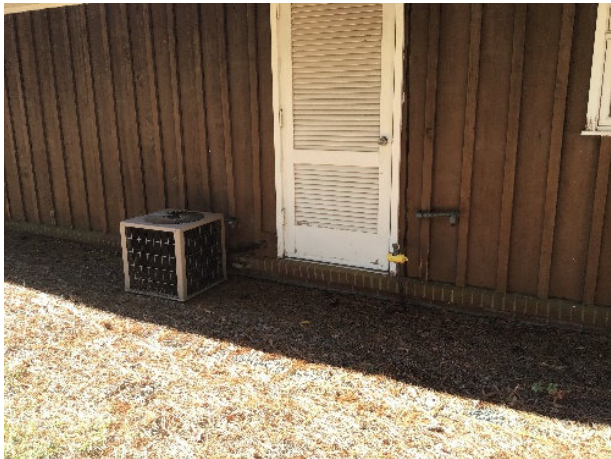
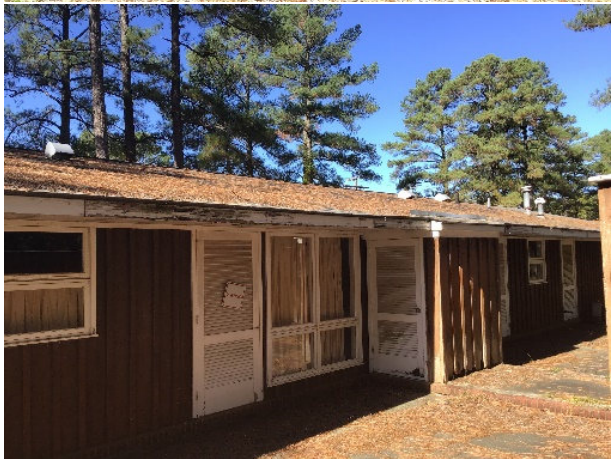
The exterior wall construction for this structure consist of wood siding and masonry end walls. The windows are wood framed with single pane glass. The doors are wood and wood louver doors. The wood siding is in fair condition and the brick portions of the wall are in good condition. The windows and doors are in poor condition and are showing signs of water damage and decay. Signs of water leakage is evident at the window/frame connections and at the floor level of the exterior doors.

The roof is an asphalt shingle roof that is showing signs of failure. Debris and shingle deformities are evident on the roof. Our team was not able to gain access inside the building but based on the teams through the window visual inspection there were some signs of leakage, but no major leaks were observed.

This structure is in immediate need of repairs. It is unclear what damage may exist in the floor system or in the interior framing. A complete interior gut will most likely have to take place in order to mediate the mold and mildew damage. All door and windows will have to be replaced and a new roof, including some underlayment will also have to be replaced in order to save the structure from further decay. Further inspections will be required to ensure no termite damage exist.

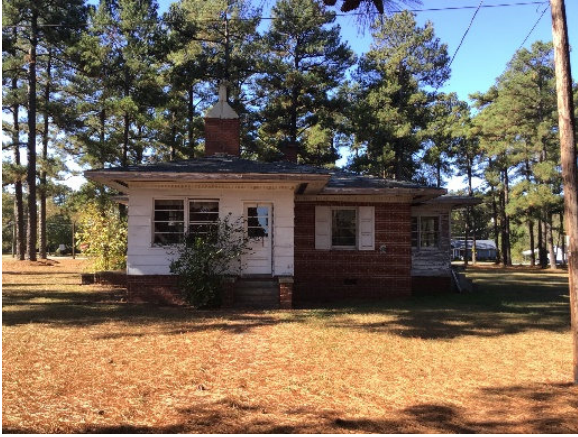
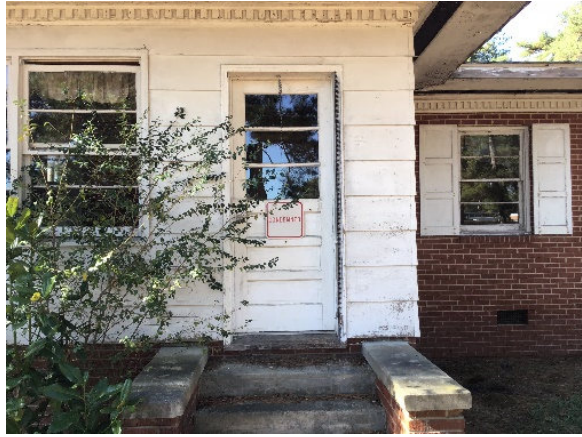
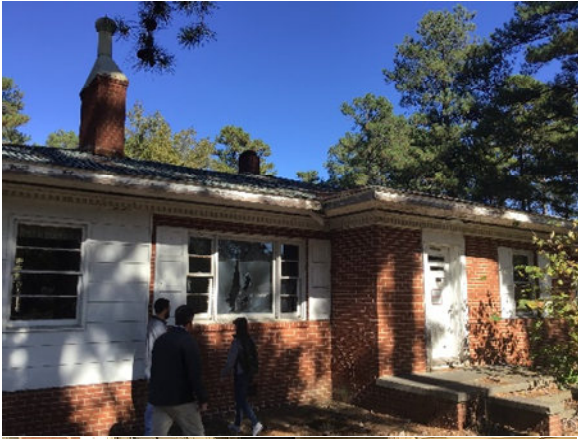
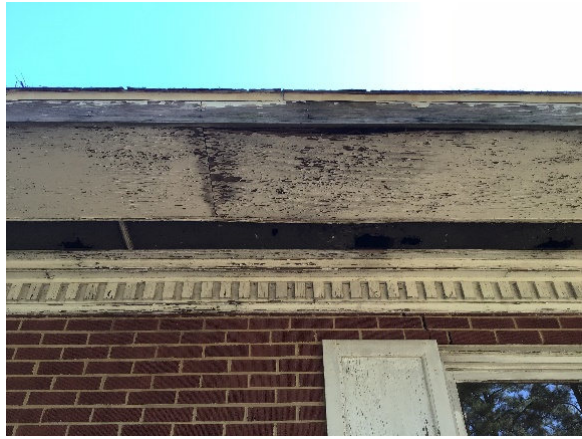
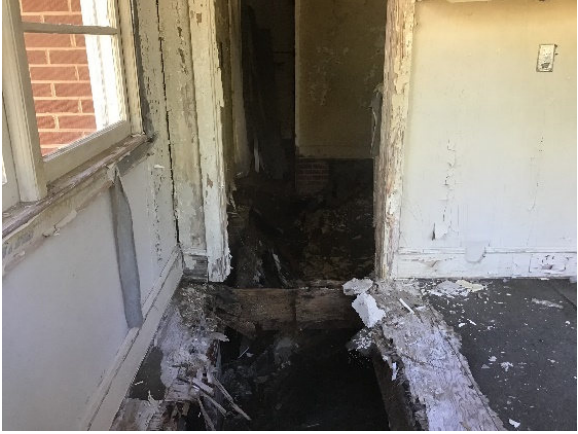
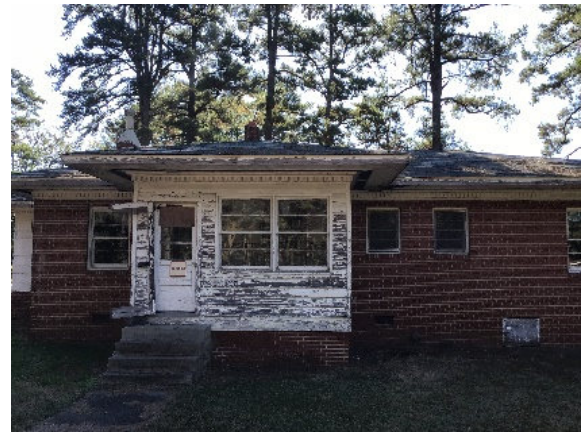
The exterior wall construction for this structure consist of brick and wood siding. The windows are wood framed with single pane glass. The doors are wood. The wood siding is in poor condition and the brick portions of the wall are in fair to good condition. The windows and doors are in poor condition and are showing signs of water damage and decay. Signs of water leakage is evident at the window/frame connections. The exterior doors are in poor condition due to water damage and lack of maintenance.

The floor system is wood framed over a crawl space. The floor is in extremely poor to non-existent condition. Due to water intrusion the floor system is not safe or usable. There are major holes in the floor and the remaining floor system is close to collapse.

The roof is an asphalt shingle roof that is failing. Debris and shingle deformities are evident on the roof. Our team was not able to gain access inside the building but based on the teams through the window visual inspection there were some major signs of leakage.

This structure is beyond practical repair and should be demolished.

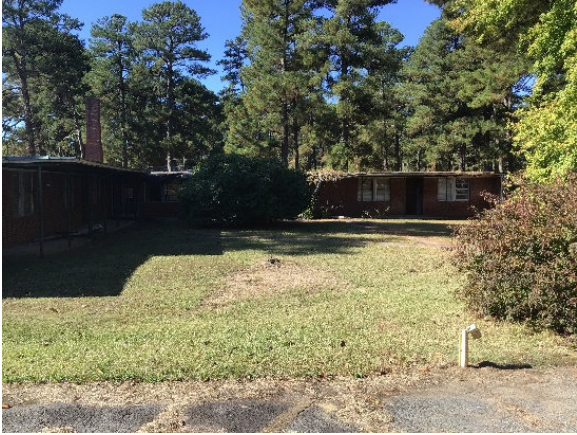
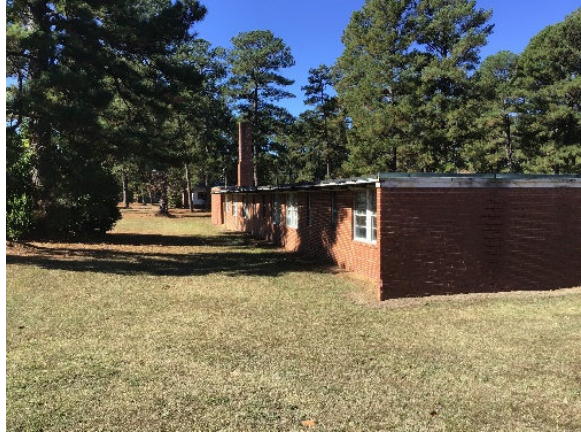
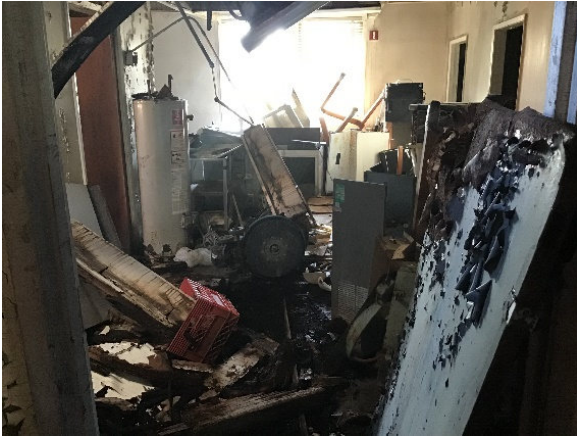
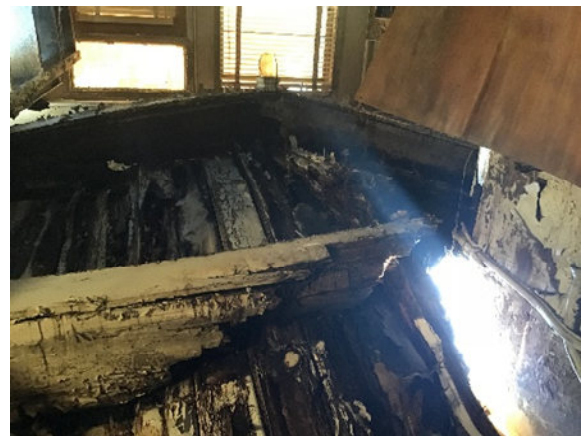
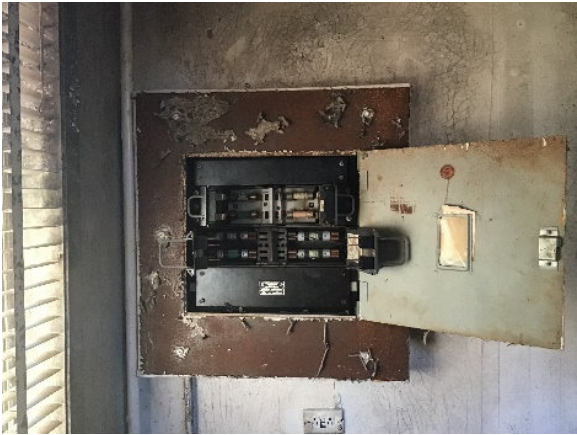
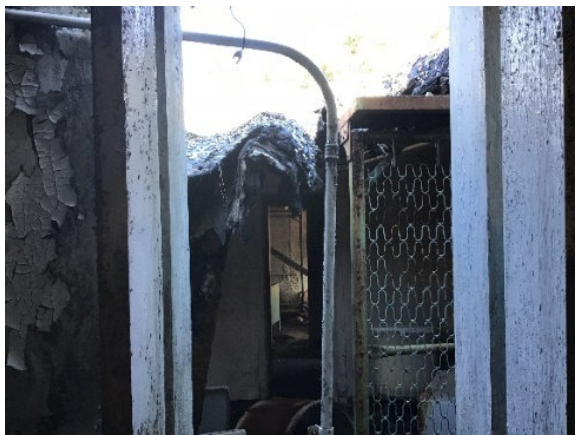
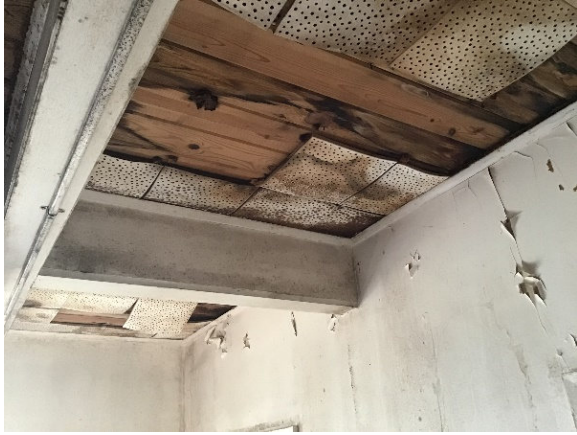
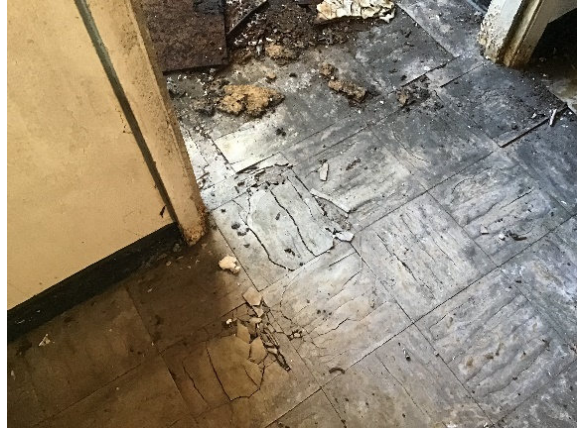
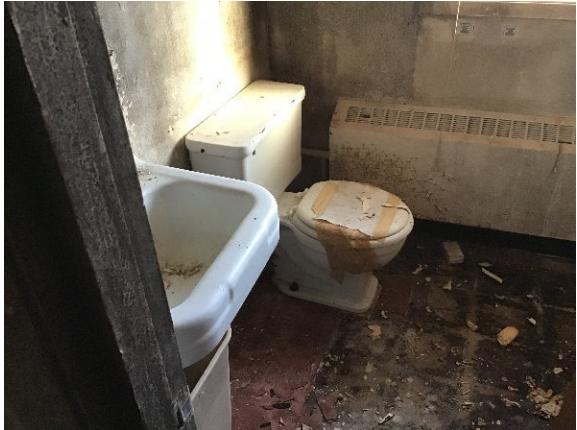
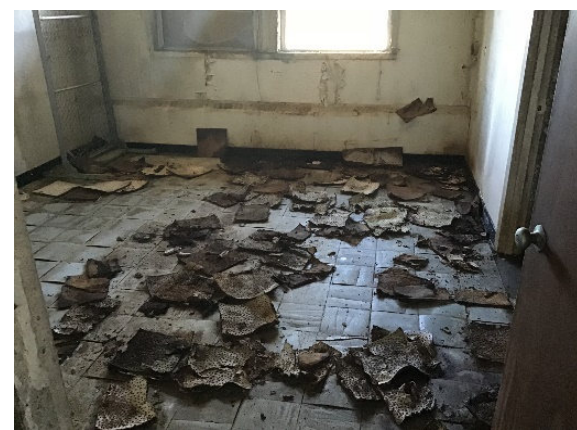
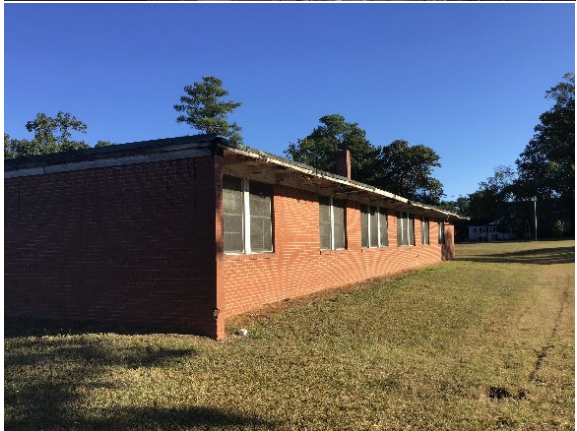
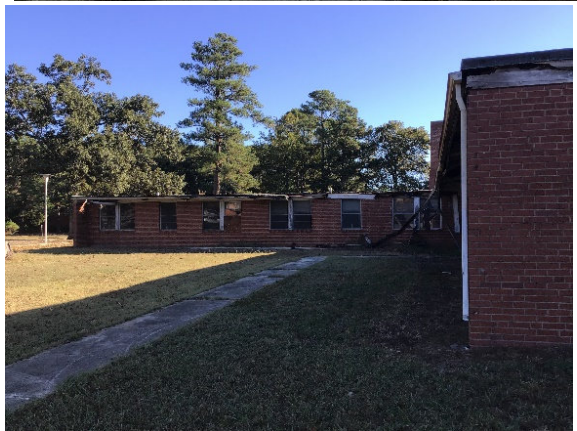
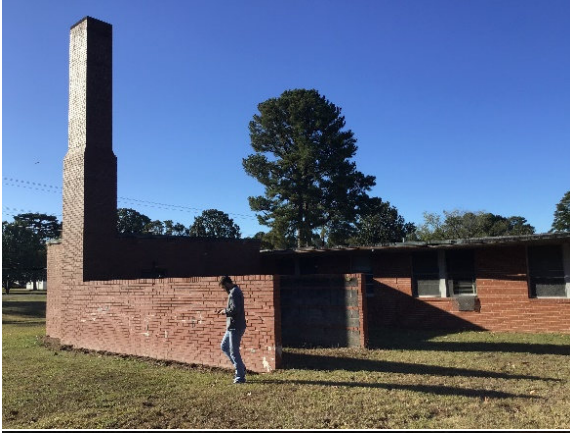
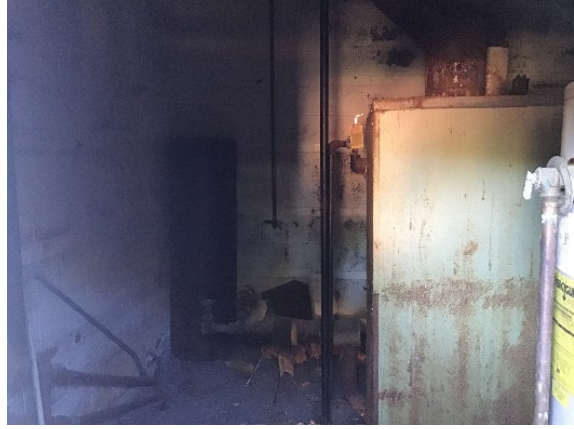
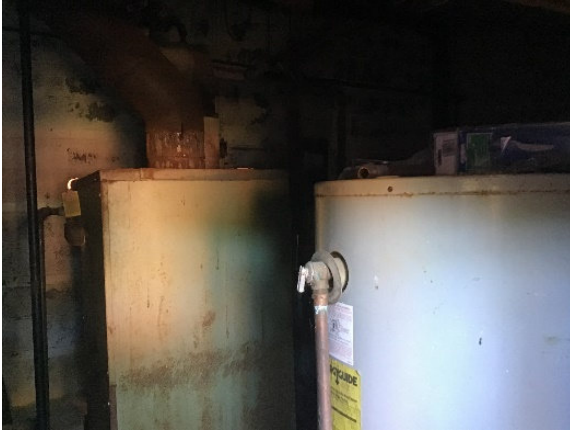
The exterior wall construction for this structure is load bearing masonry. The windows are metal framed with single pane glass. The doors are wood and metal. The windows and doors are in poor condition and are rusting or have water damage. Signs of water leakage is evident at the window/frame connections. The exterior doors are in poor to non-existent condition. Generally, the exterior wall is in fair condition although signs of water intrusion are evident.

The floor system is a concrete slab on grade with tile floors. The condition of the slab is unknown due to the amount of building debris from furnishings and the roof. The tile has been soaked with water and is no longer adhered to the slab.

The roof is an asphalt built up roof. The roof has failed and has collapsed in many locations. In locations that have not collapsed the wood structure is beyond the point of repair and will need to be replaced.

These structures are beyond practical repair and should be demolished.

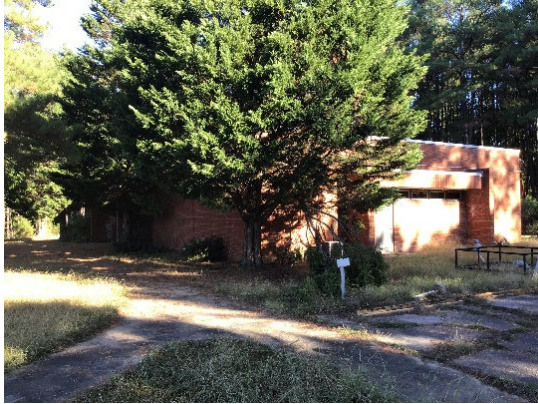
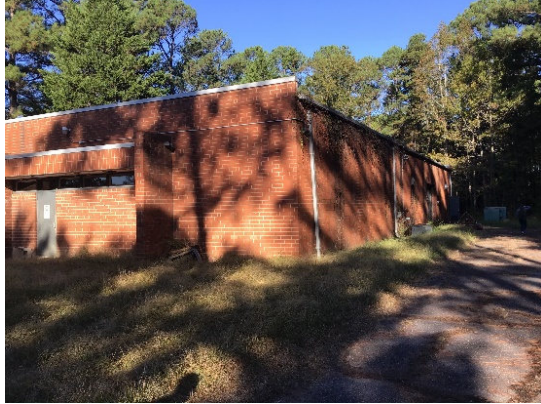
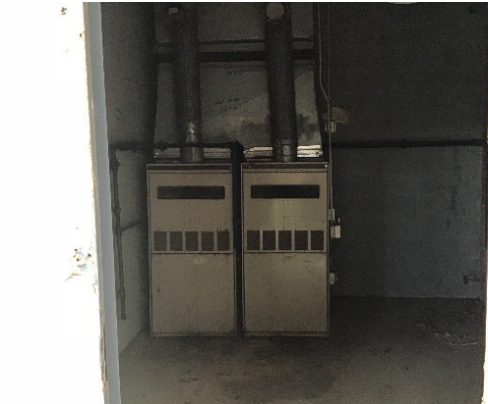
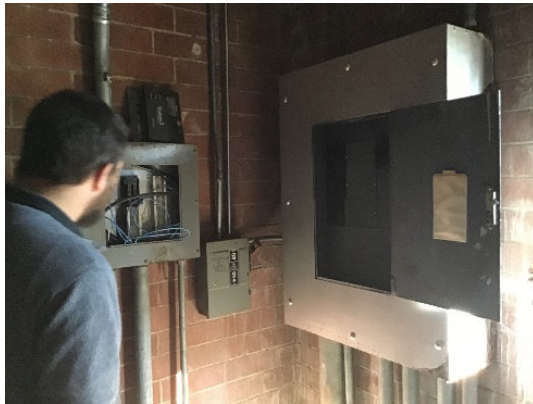
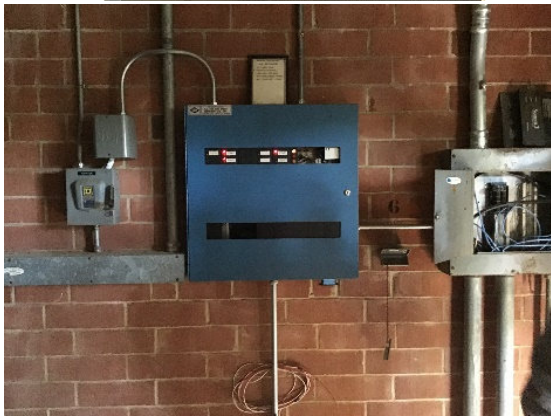
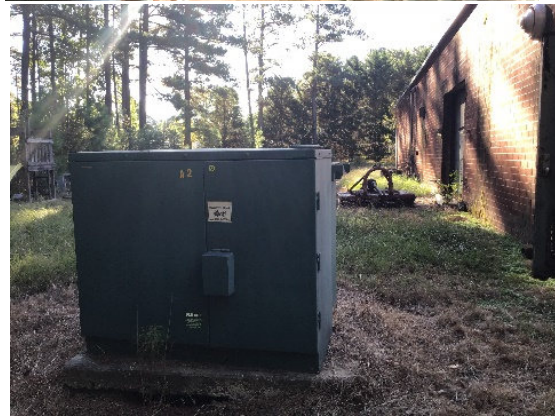
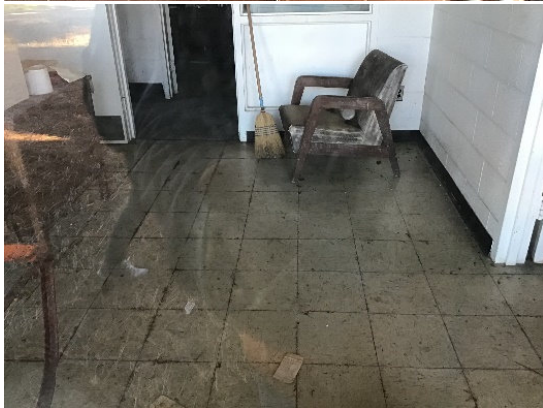
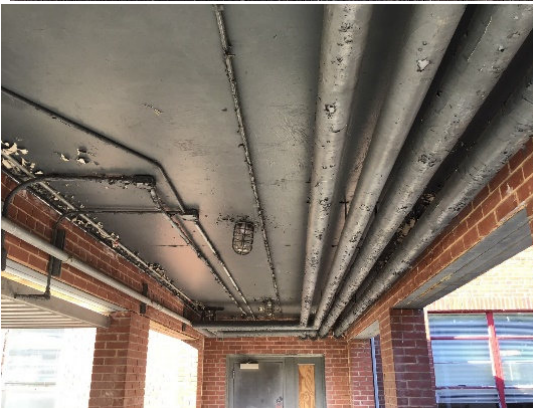
The floor system is a slab on grade and is in generally good condition except for being wet from the various leaks in the roof and walls.

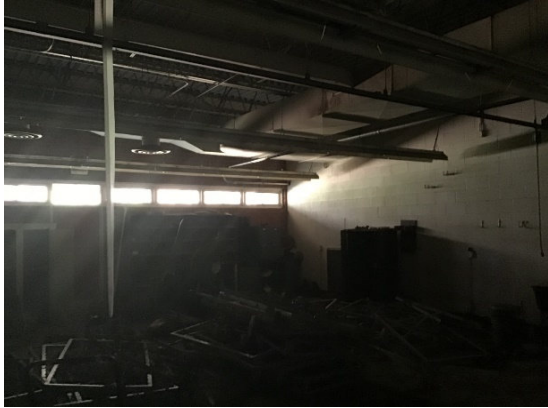
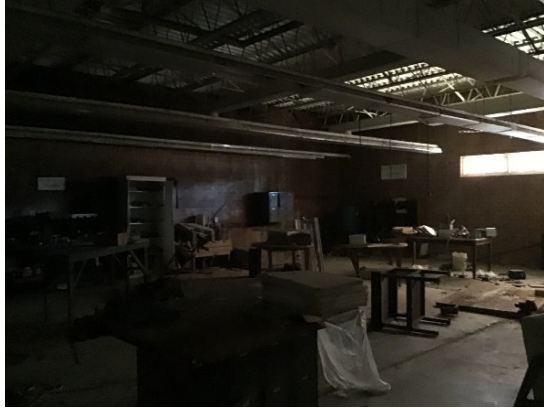
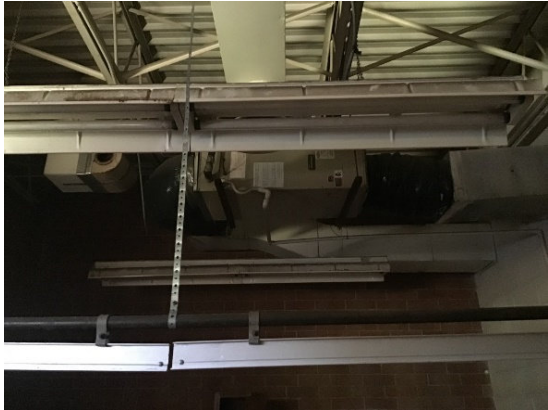
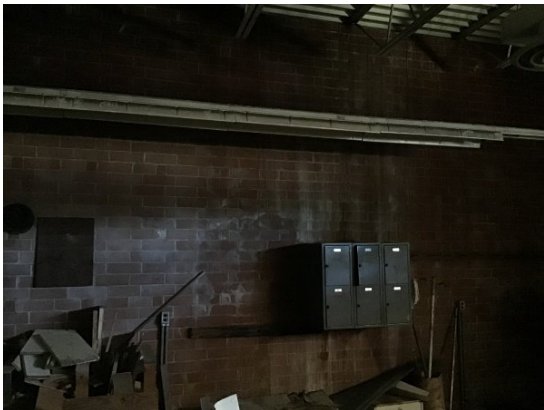
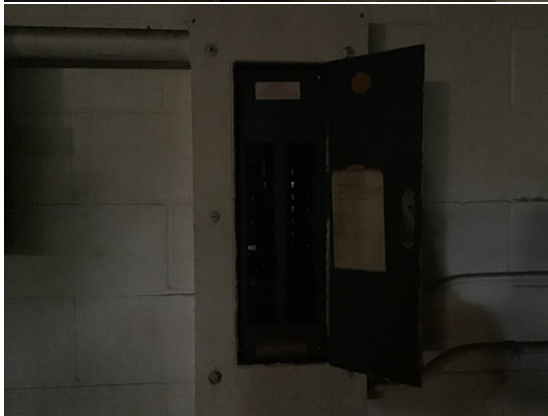
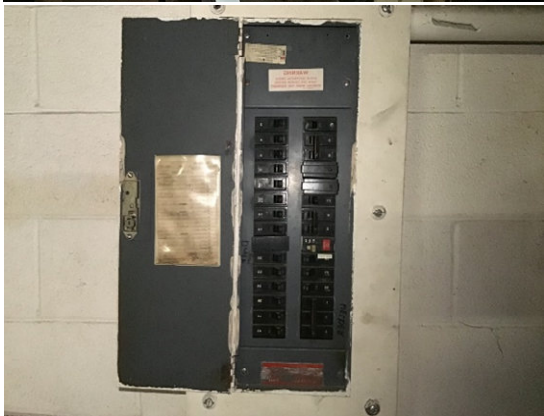
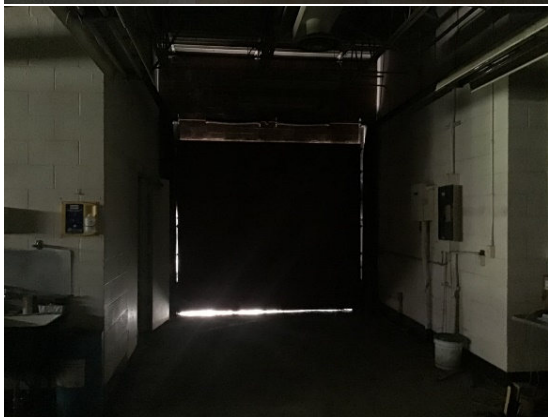
The exterior wall construction for this structure consist of brick and block. The windows are aluminum framed with insulated pane glass. The doors are storefront and metal. The windows and doors are in fair condition and are rusting or have water damage. Signs of water leakage is evident at the exterior wall/roof intersection and interior to the roof in several places. The exterior sectional doors are in poor condition. Generally, the exterior wall is in fair condition although signs of water intrusion are evident.

The roof is a membrane roof of some type. The structure for the roof is steel joist and is a single slope to the rear. Signs of water leakage is evident at the exterior wall/roof intersection and interior to the roof in several places.

This structure is in fair condition and could be repaired for future use. Mold and mildew remediation must occur once any leaks have been repaired.

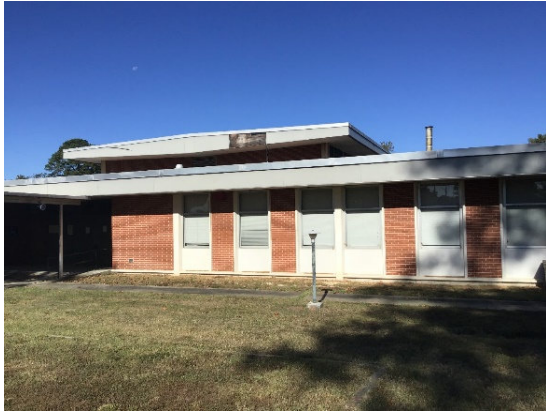
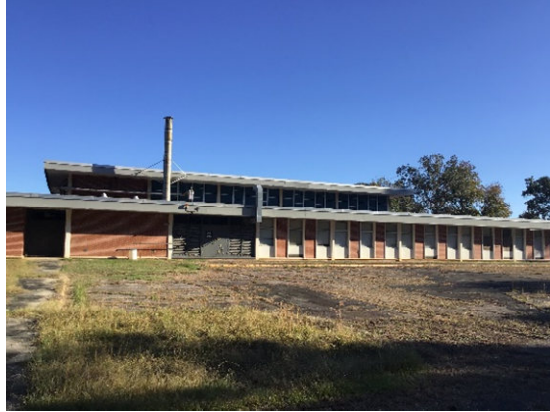
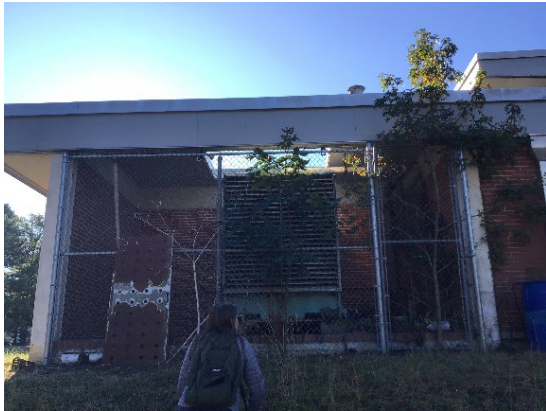
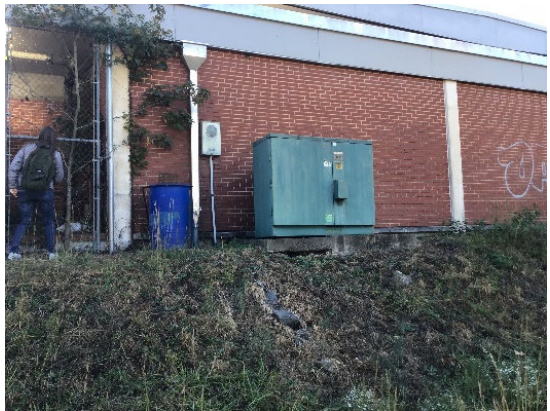
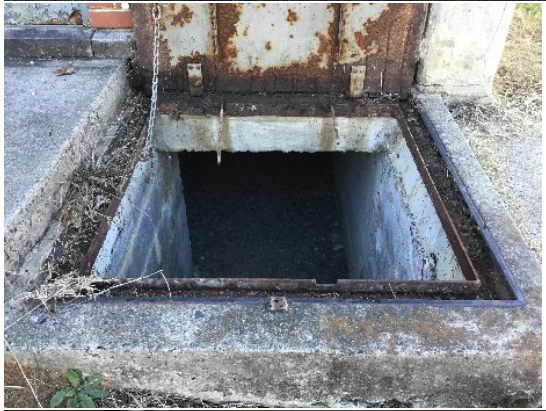
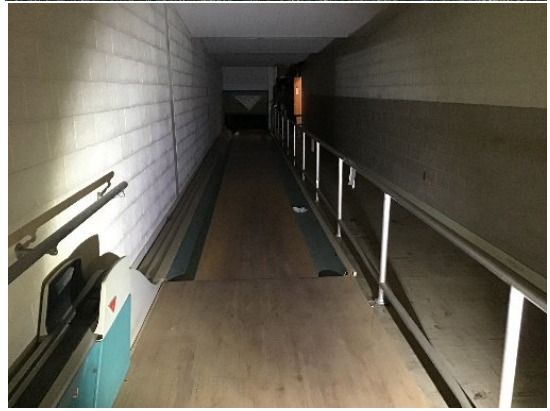
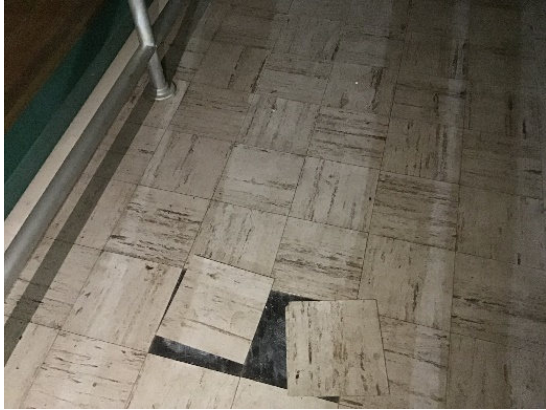
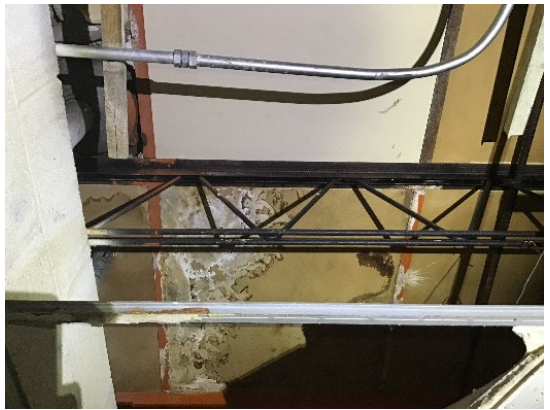
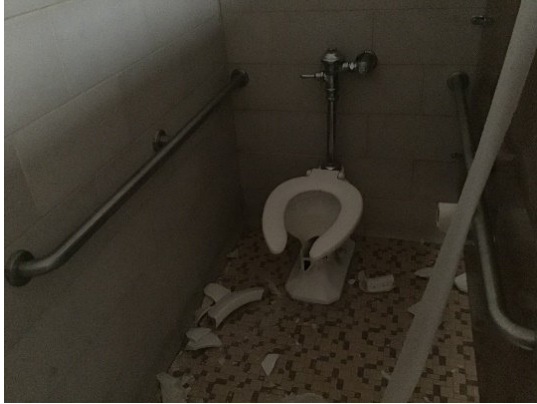
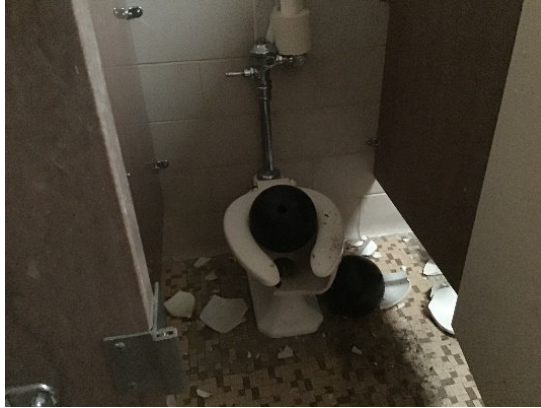
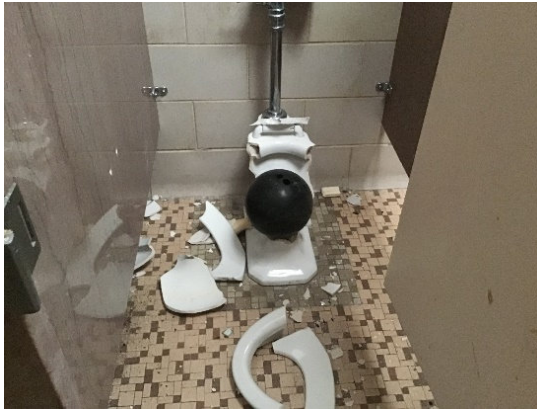
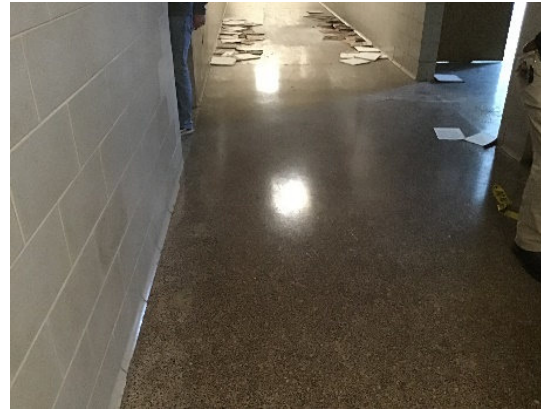
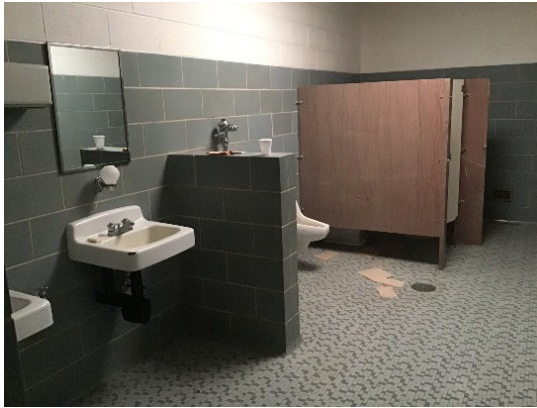
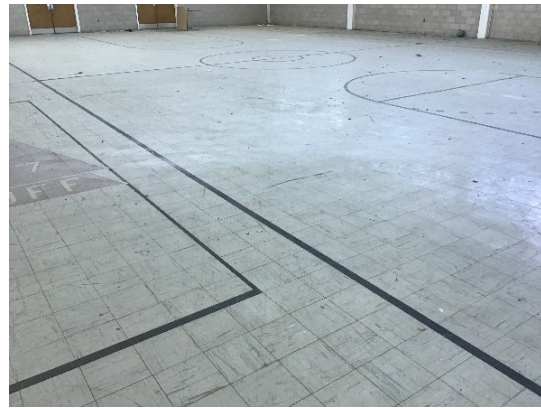
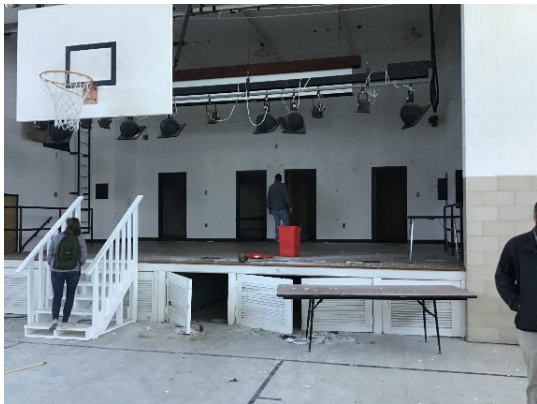
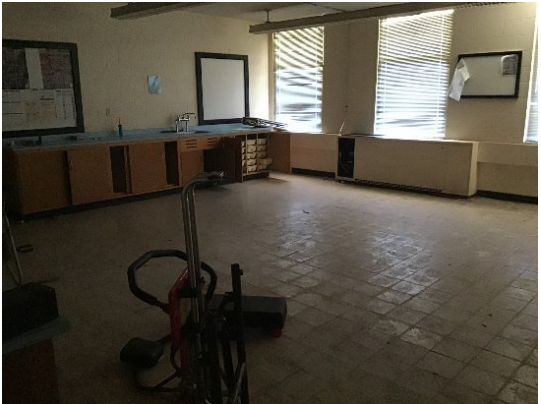
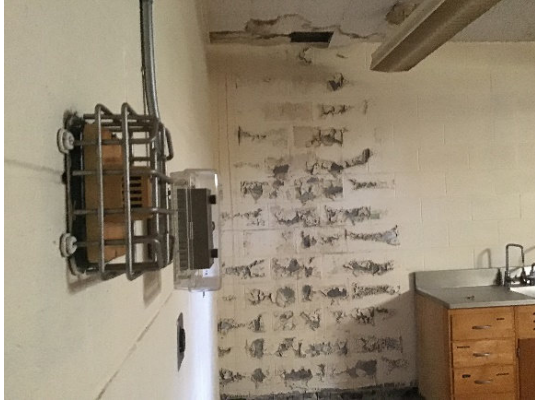
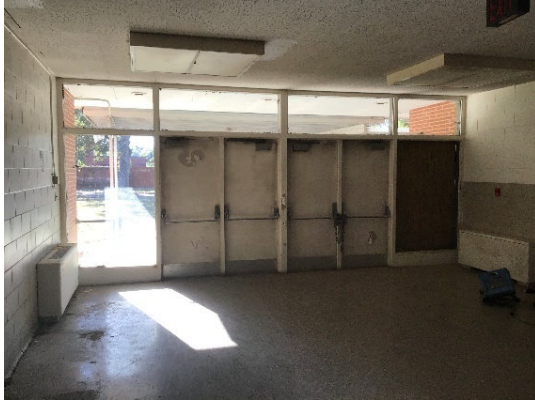
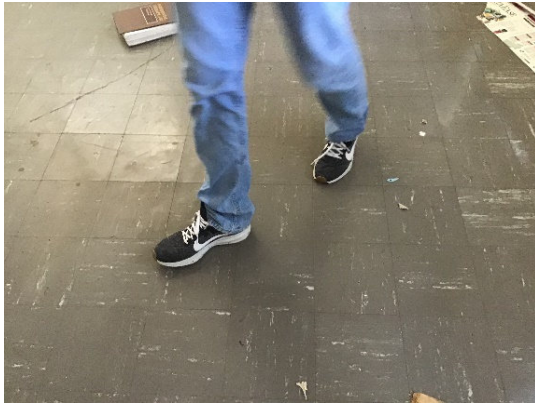
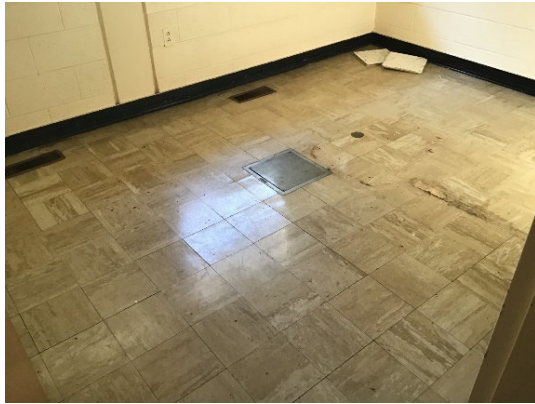
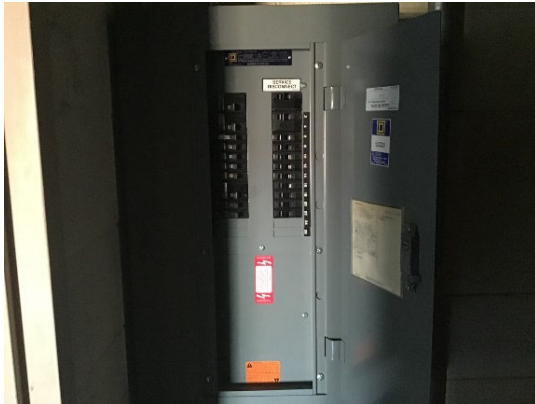
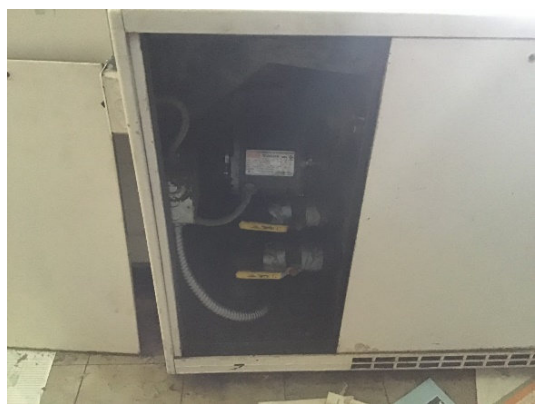
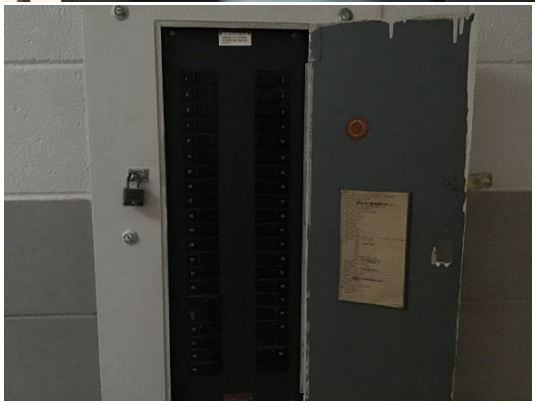
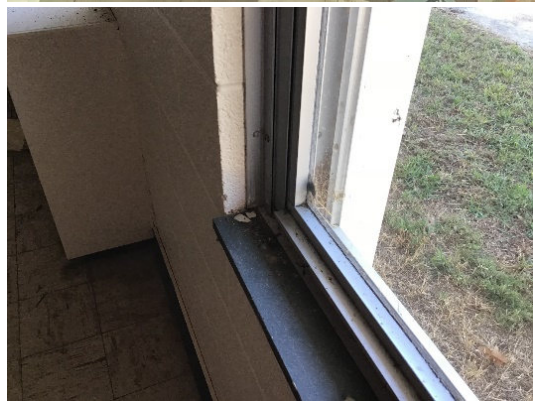
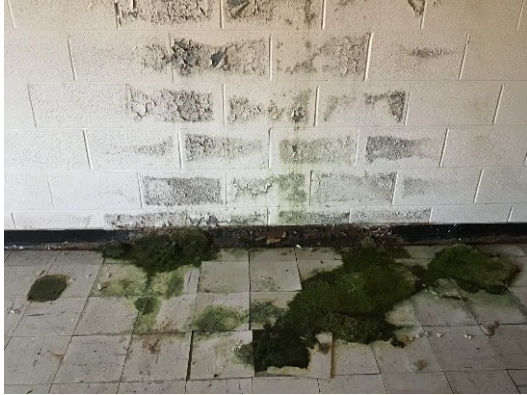
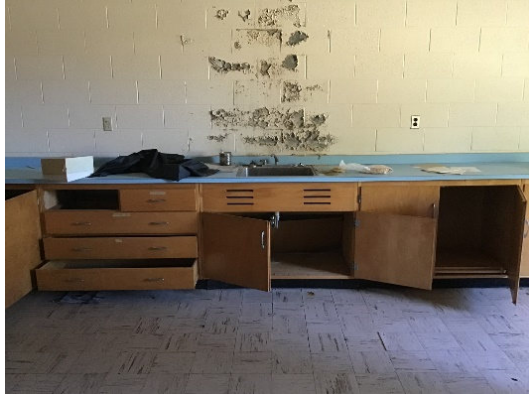
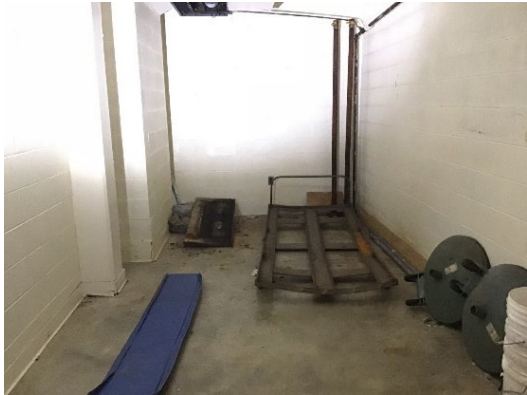
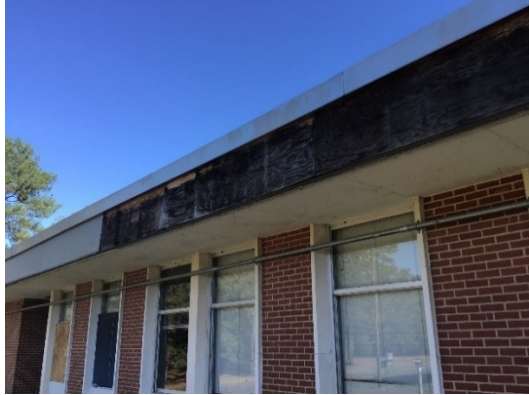
Gymnasium #6

The exterior wall construction for this structure consist of brick and block with a metal panel soffit facia. The windows are metal, and aluminum framed with mostly insulated pane glass. The doors are hollow metal and metal. The windows and doors are in fair condition with some insulated glass panels that have broken seals. Generally, the exterior wall is in fair condition although signs of water intrusion are evident. There are several areas of the soffit that the facia has fallen off and has been exposed to the weather for some time. These areas will have to be repaired or completely replaced.

The floor system is a slab on grade and over the mechanical tunnel/crawl space system and is in generally good condition. There is a mix of terrazzo and VCT tiles that make up the floor finish.

The roof system is a membrane of some type, most likely EPDM/TPO and built up roof combination. The structure for the roof is steel joist. The roof is leaking in some areas throughout the building. Insulation will most likely have to be replaced due to moisture content during any roof replacement.

This structure is in fair condition and could be repaired for future use. Mold and mildew remediation must occur once any leaks have been repaired.
