Umstead Correctional Center Building Assessment

Prepared for
The Town of Butner, North Carolina

12-18-19

HagerSmith Design

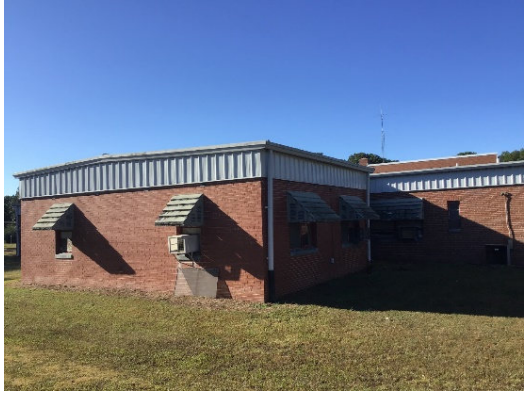
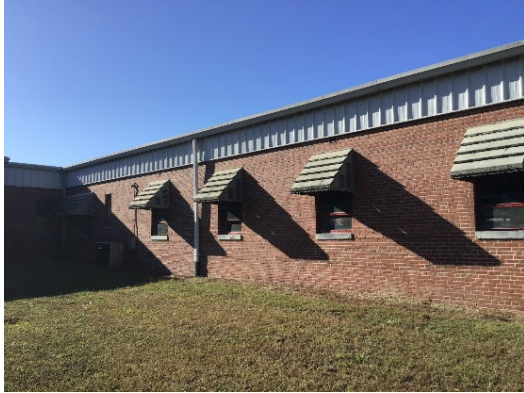
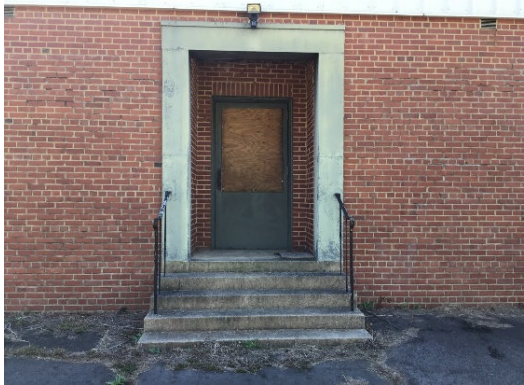
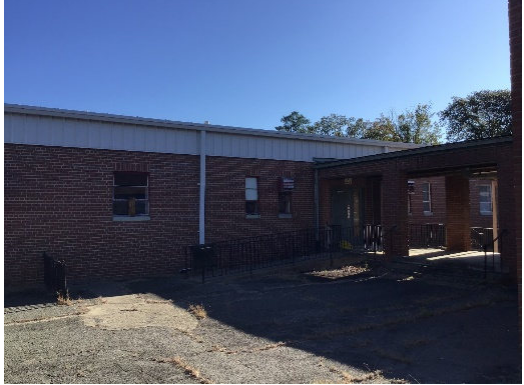
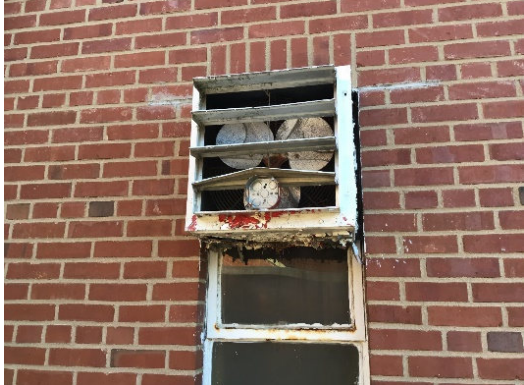
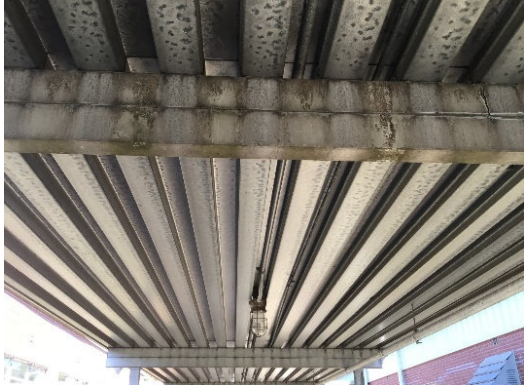
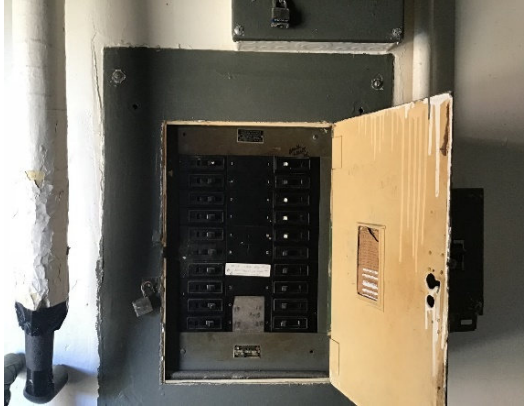
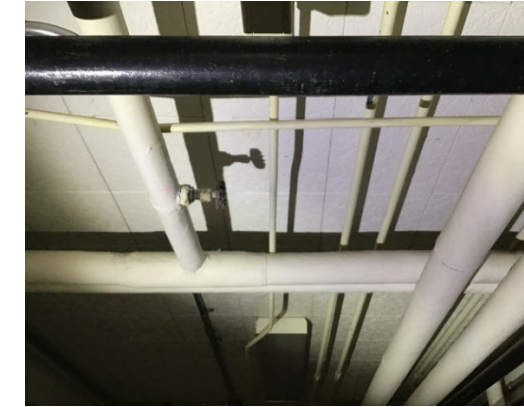
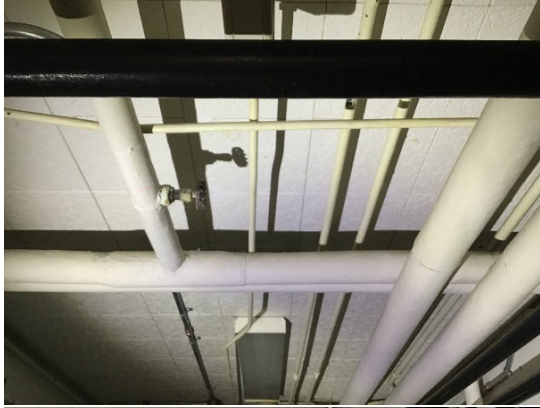
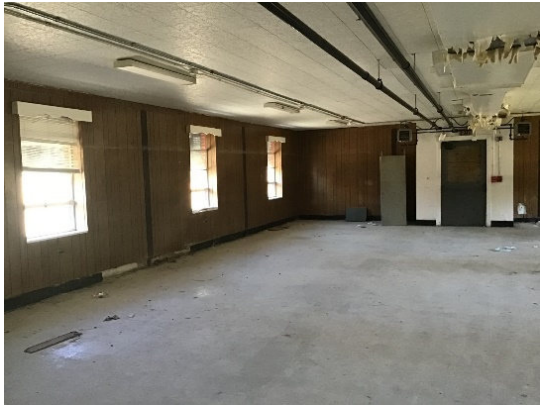
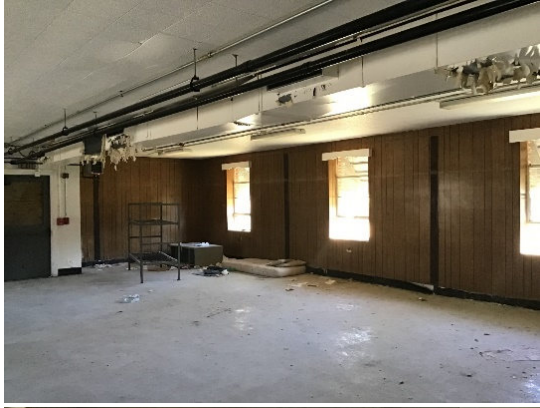
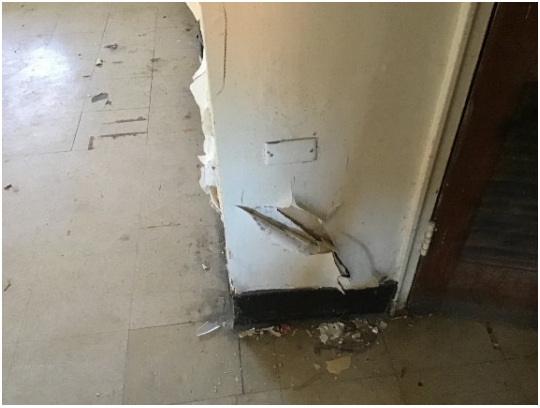
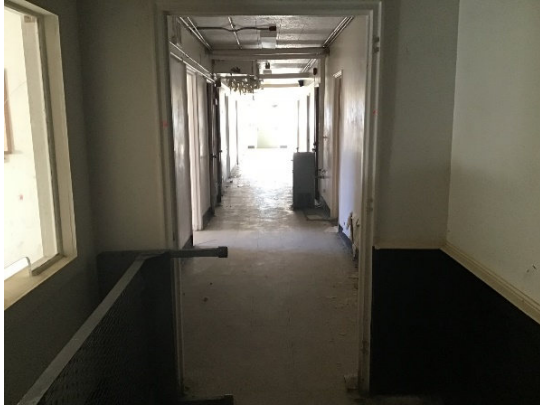
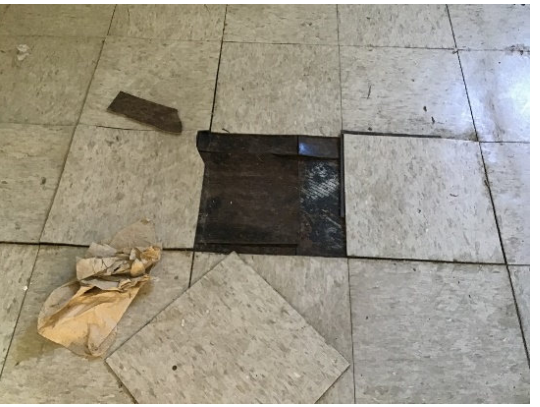
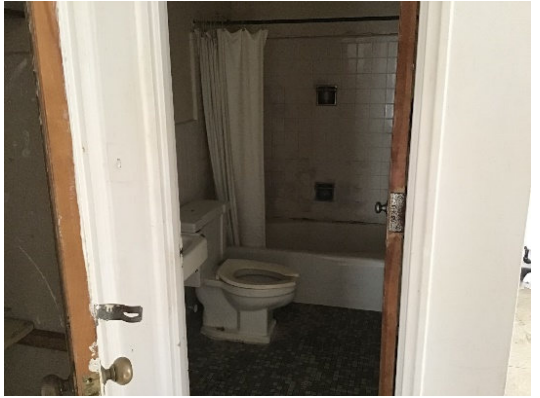
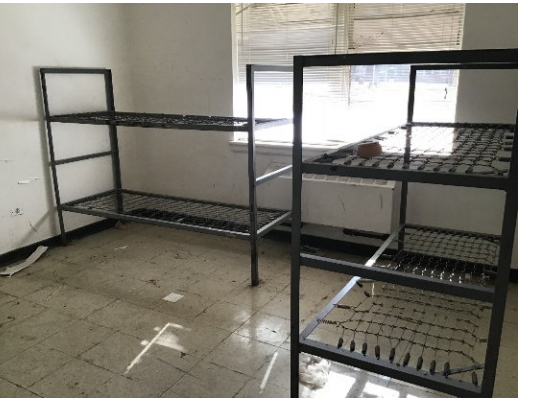
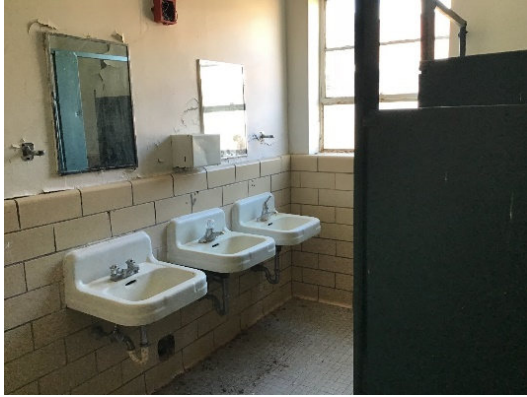
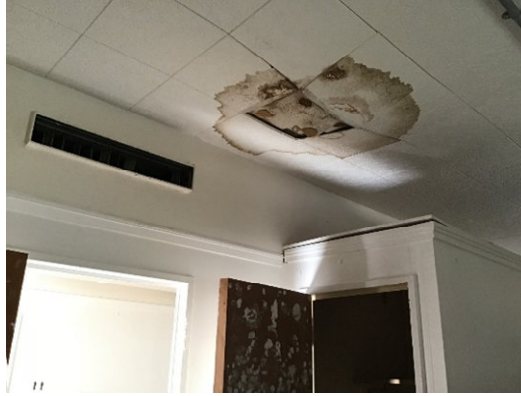
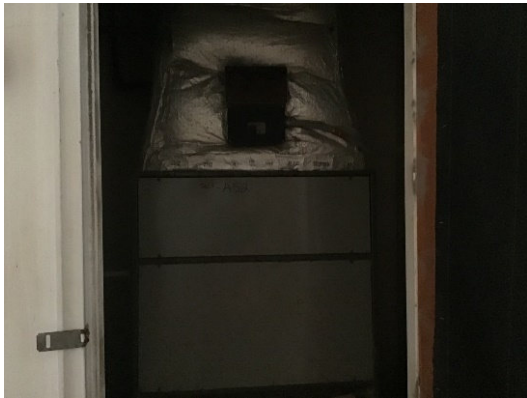
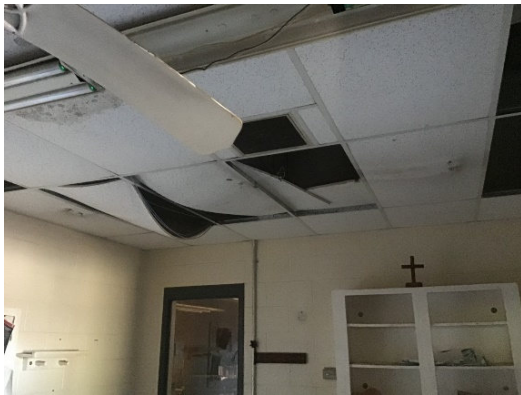
The exterior wall construction for this structure consist of brick and block. The windows are metal framed with non-insulated pane glass. The doors are hollow metal and metal. The windows and doors are in poor condition with signs of water and rust damage. Generally, the exterior wall is in fair condition although signs of water intrusion are evident.

The floor system is an elevated slab and over a partial crawl space and is in generally good condition. There are VCT tiles that make up the floor finish.

This structure is in fair condition and could be repaired for future use. There is evidence of water damage throughout the building. This damage most likely occurred prior to the installation of the new metal roof. Mold and mildew remediation must occur once any leaks have been repaired.

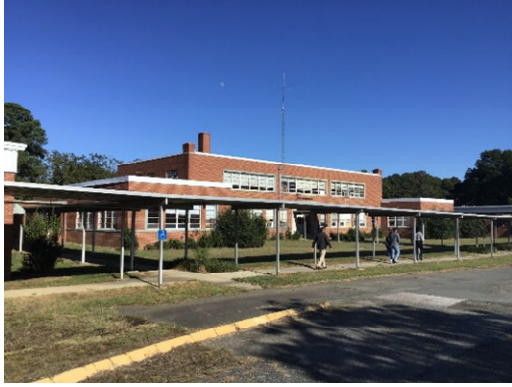
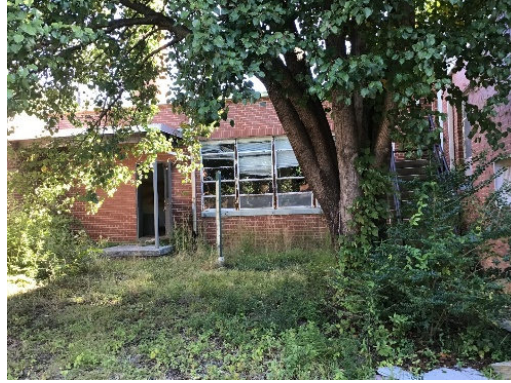
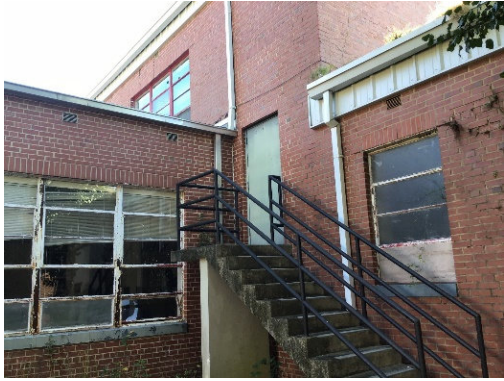
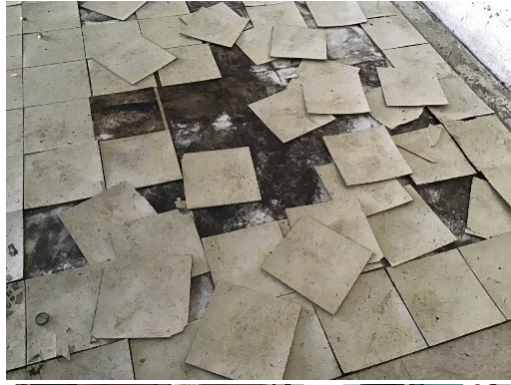
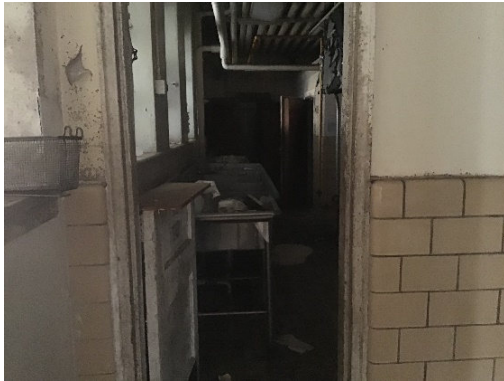
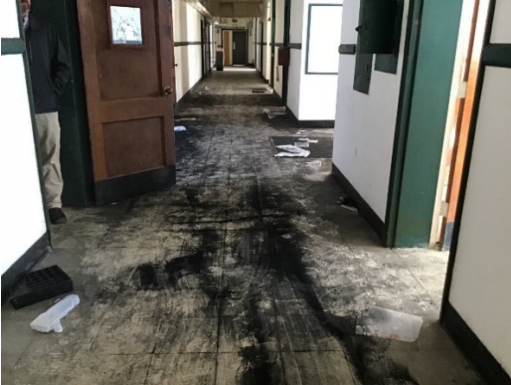
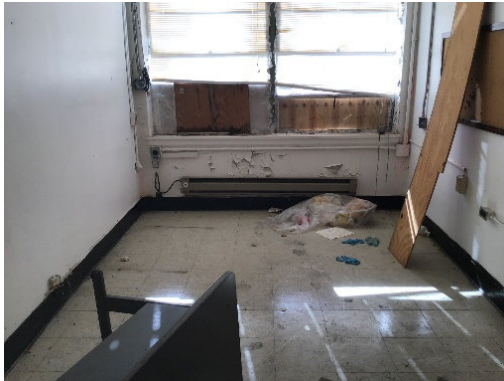
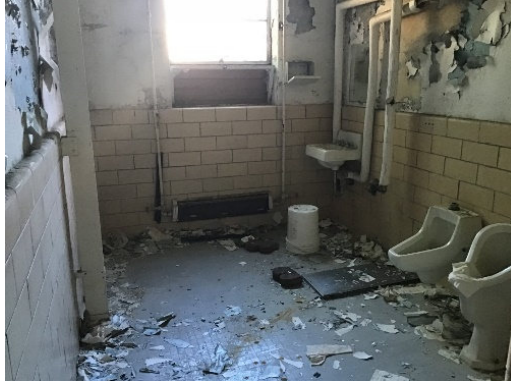
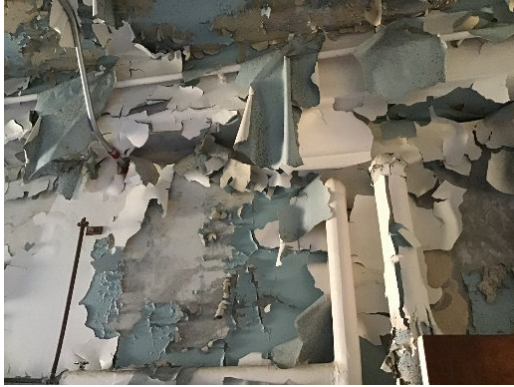
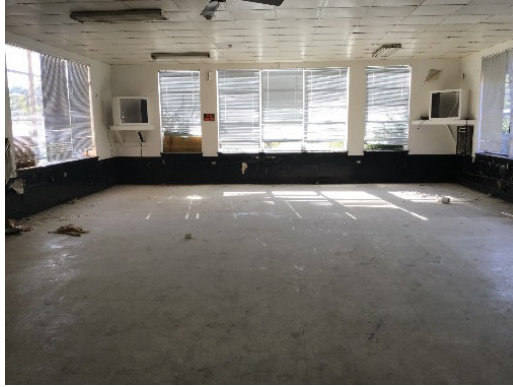
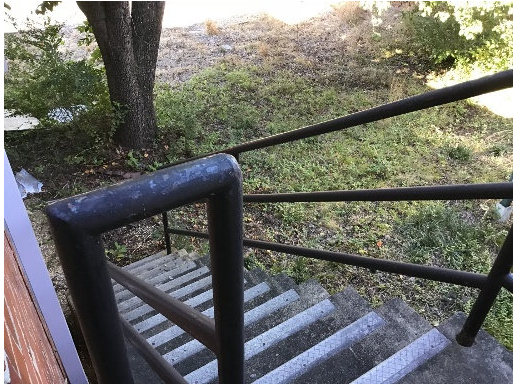
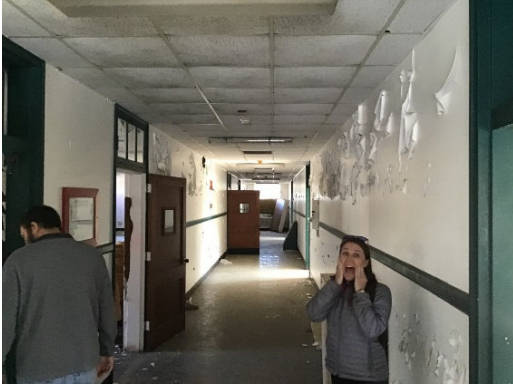
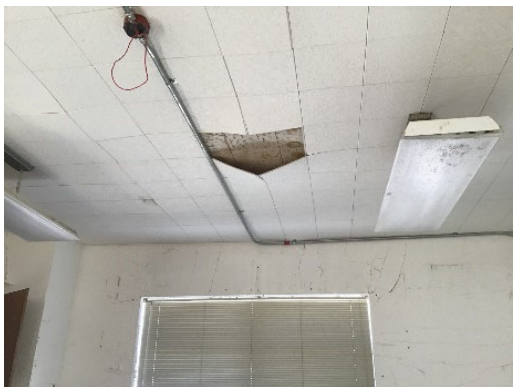
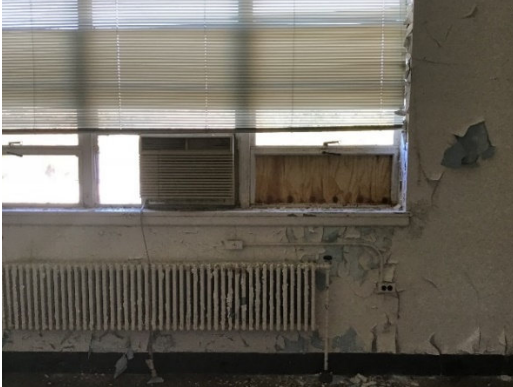
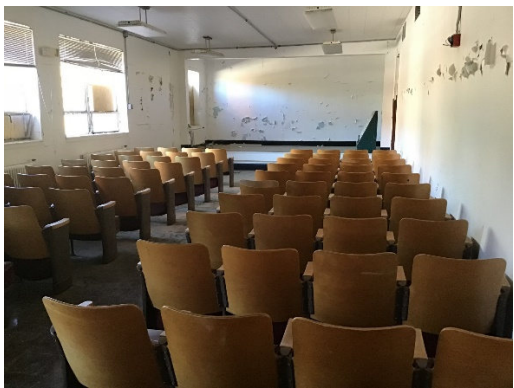
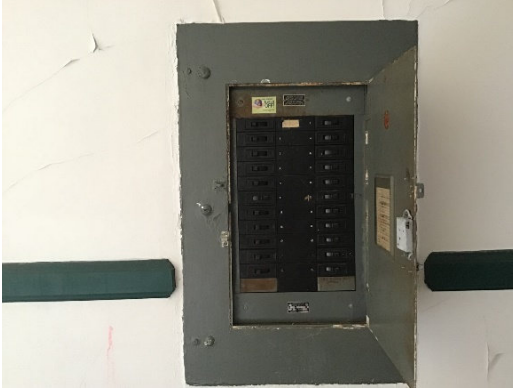
Administration/Classroom #8

The exterior wall construction for this structure consist of brick and block. The windows are metal framed with non-insulated pane glass. The doors are hollow metal and metal. The windows and doors are in poor condition with signs of water and rust damage. Generally, the exterior wall is in fair condition although signs of water intrusion are evident.

The floor system is an elevated slab and over a partial crawl space and is in generally good condition. There are VCT tiles that make up the floor finish. There are several windows that have been broken and remain open.

This structure is in fair condition and could be repaired for future use. There is evidence of water damage throughout the building. This damage most likely occurred prior to the installation of the new metal roof. Mold and mildew remediation must occur with any repairs.

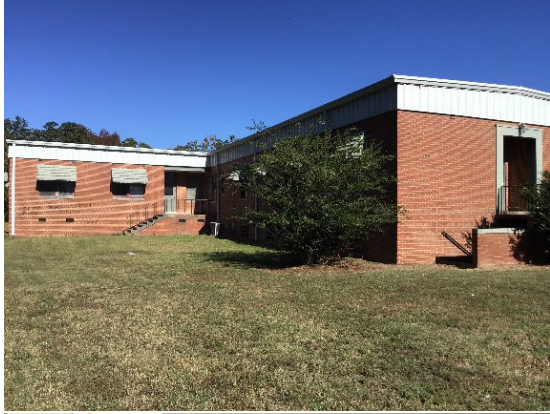
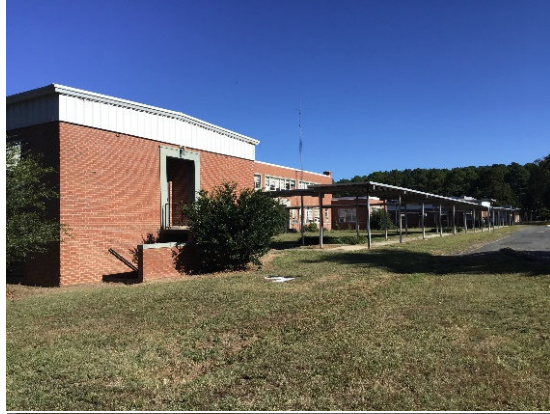
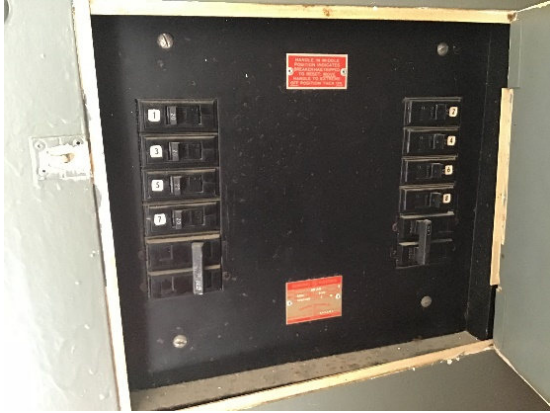
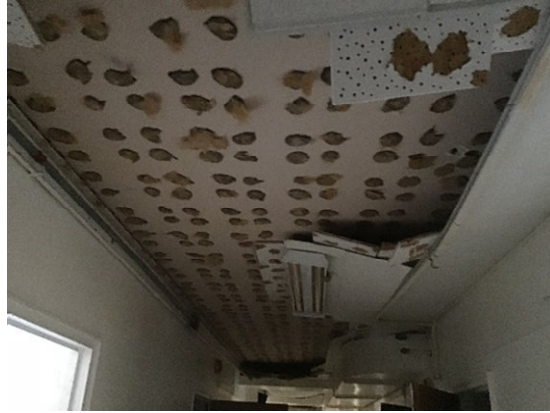
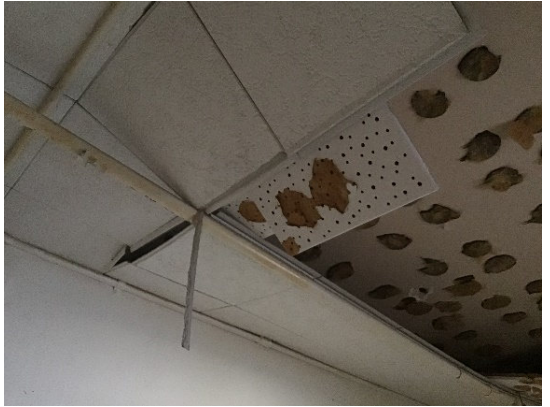
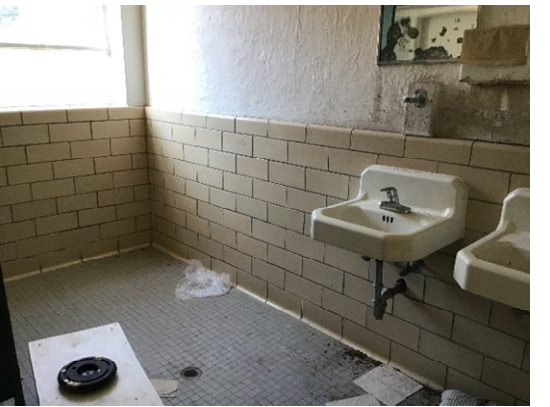
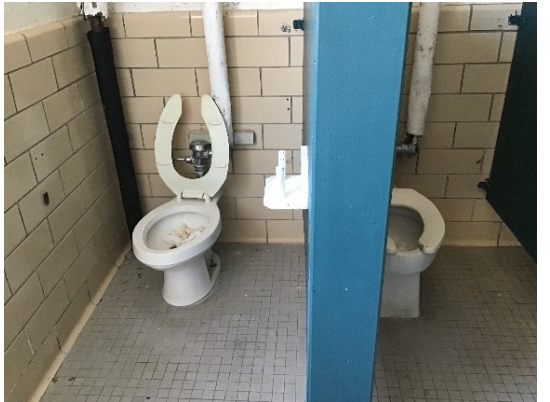
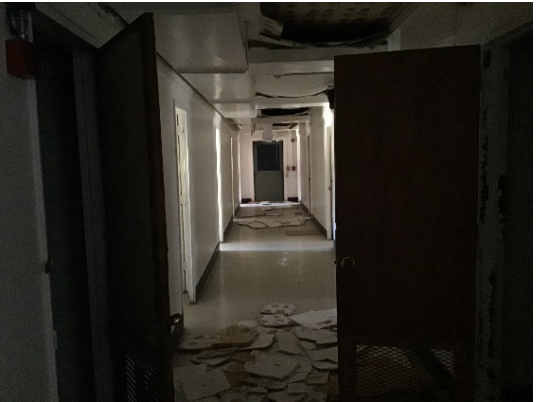
The exterior wall construction for this structure consist of brick and block. The windows are metal framed with non-insulated pane glass. The doors are hollow metal and metal. The windows and doors are in poor condition with signs of water and rust damage. Generally, the exterior wall is in fair condition although signs of water intrusion are evident.

The floor system is an elevated slab and over a partial crawl space and is in generally good condition. There are VCT tiles that make up the floor finish.

This structure is in fair condition and could be repaired for future use. There is evidence of water damage throughout the building. This damage most likely occurred prior to the installation of the new metal roof. Mold and mildew remediation must occur once any leaks have been repaired.

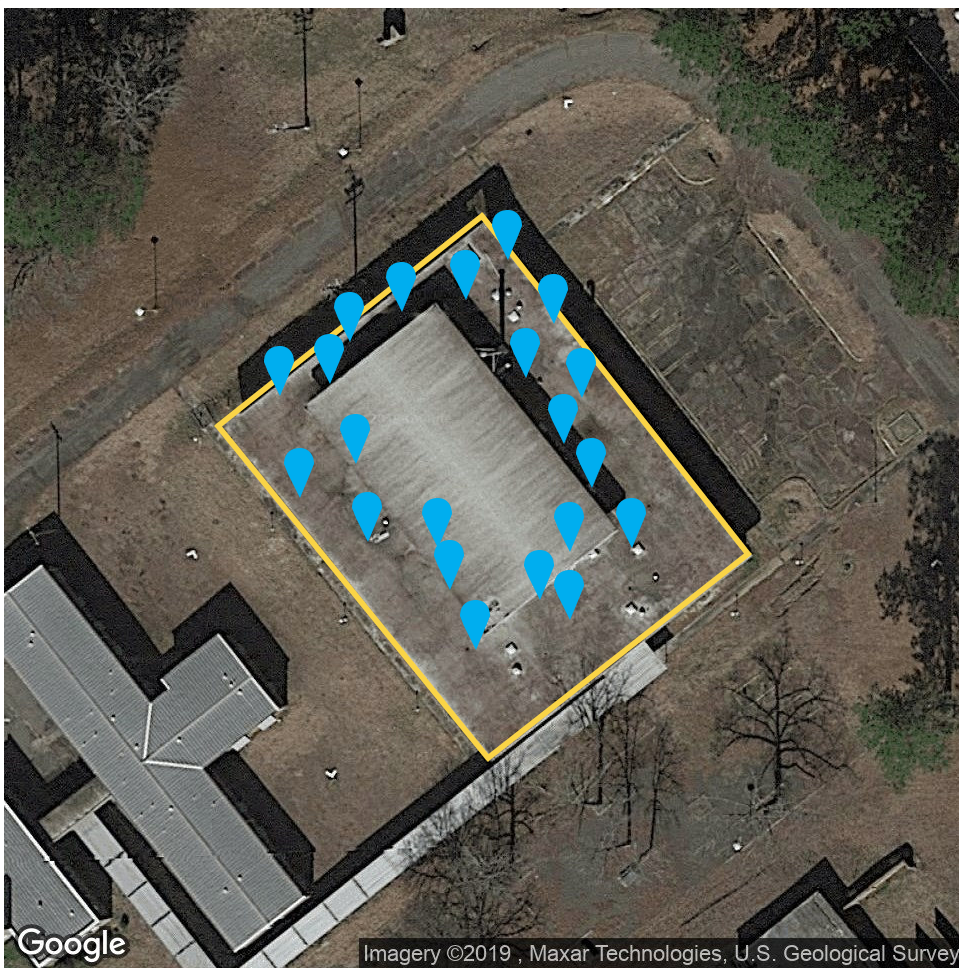
Section A Overview:

Replace

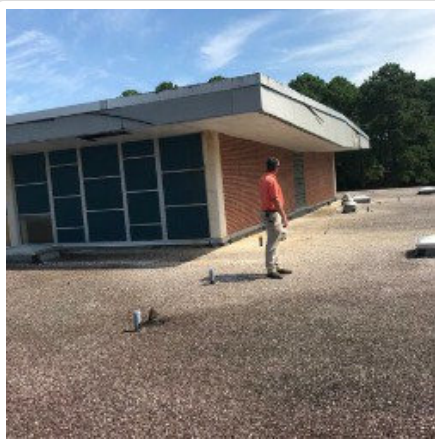
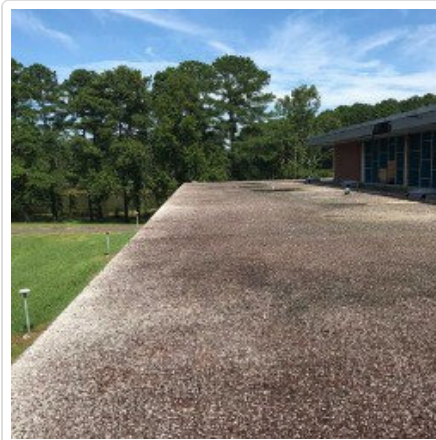
Front-side roof area.

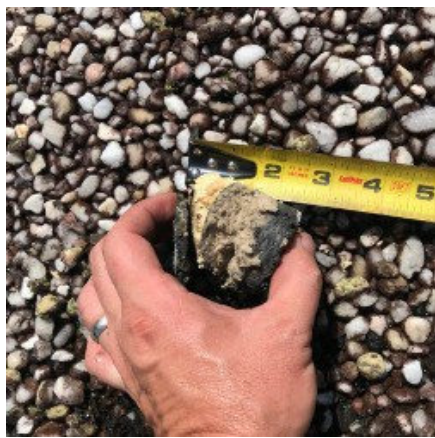
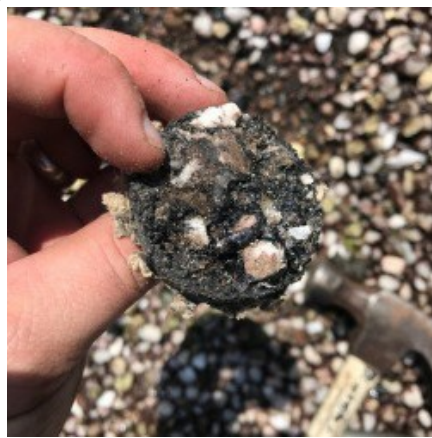
Detail:
Roof Composition

Description:
Image of roof composition (2.5") over concrete deck.

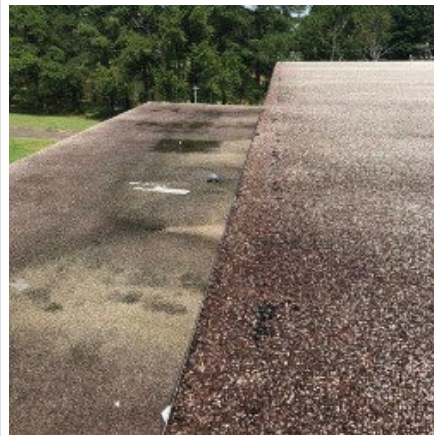
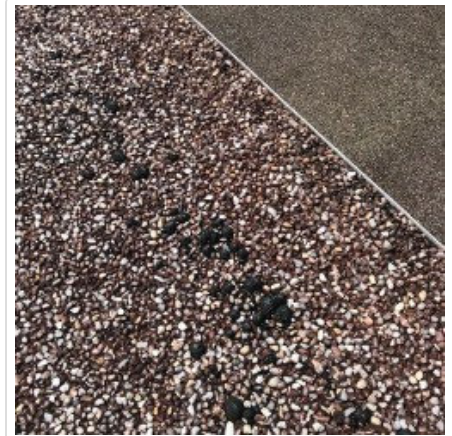
The cracking of the surfacing bitumen asphalt which occurs during the aging process in which the loss of volatile oils and the oxidation brought about by solar radiation; produces a pattern of cracks similar to an alligator's hide. The cracks may or may not extend through the surfacing bitumen.

When alligatoring cracks extend through the entire waterproofing surface, the underlying felts can become exposed to moisture, which will progressively cause the strength in the felts to decrease. Splitting of the roof membrane may result.

Requires Repair

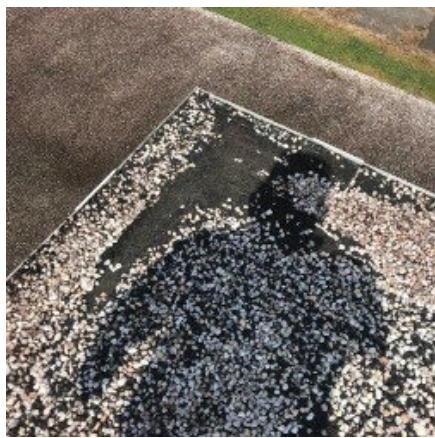
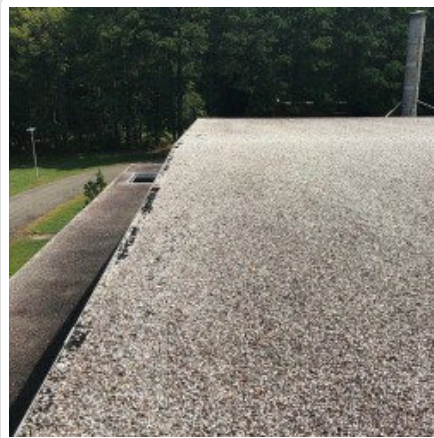
A roof top environment that is rich with moisture and air born dirt and particulates can be the breeding ground for seeds.

These seeds can grow into vegetation with root structures that can penetrate and rupture the strongest of roof membranes, resulting in leakage into the roof system and the building's interior.

Requires Repair

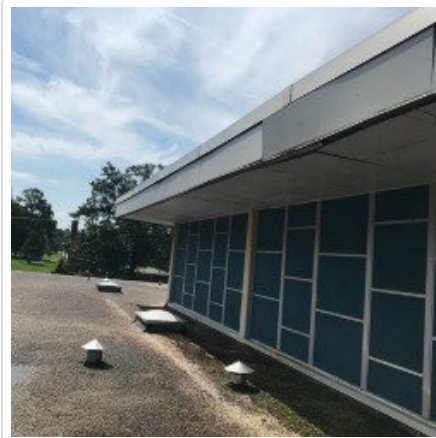
Clogged drains impede positive drainage and result in the development of ponding water conditions. Additional water adds weight to the roofing system. This condition requires immediate correction. In its extreme, this could result in deck deflection or roof collapse.

Requires Repair

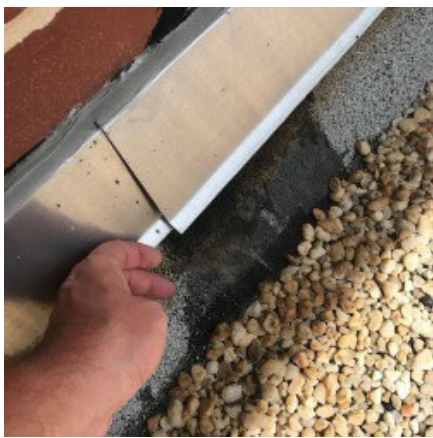
Figure 1

Issue AI-18: Flashing defect - crazed and cracked

Flashings exhibit a crazed or cracked appearance in the top layer of the flashings surface. Extended exposure to UV rays over time causes the flashing to split.

Requires Repair
